## RETENTION POND CALCS.

DRAINAGE DOCUMENTATION.

# BIOLOGICAL ASSESSMENT

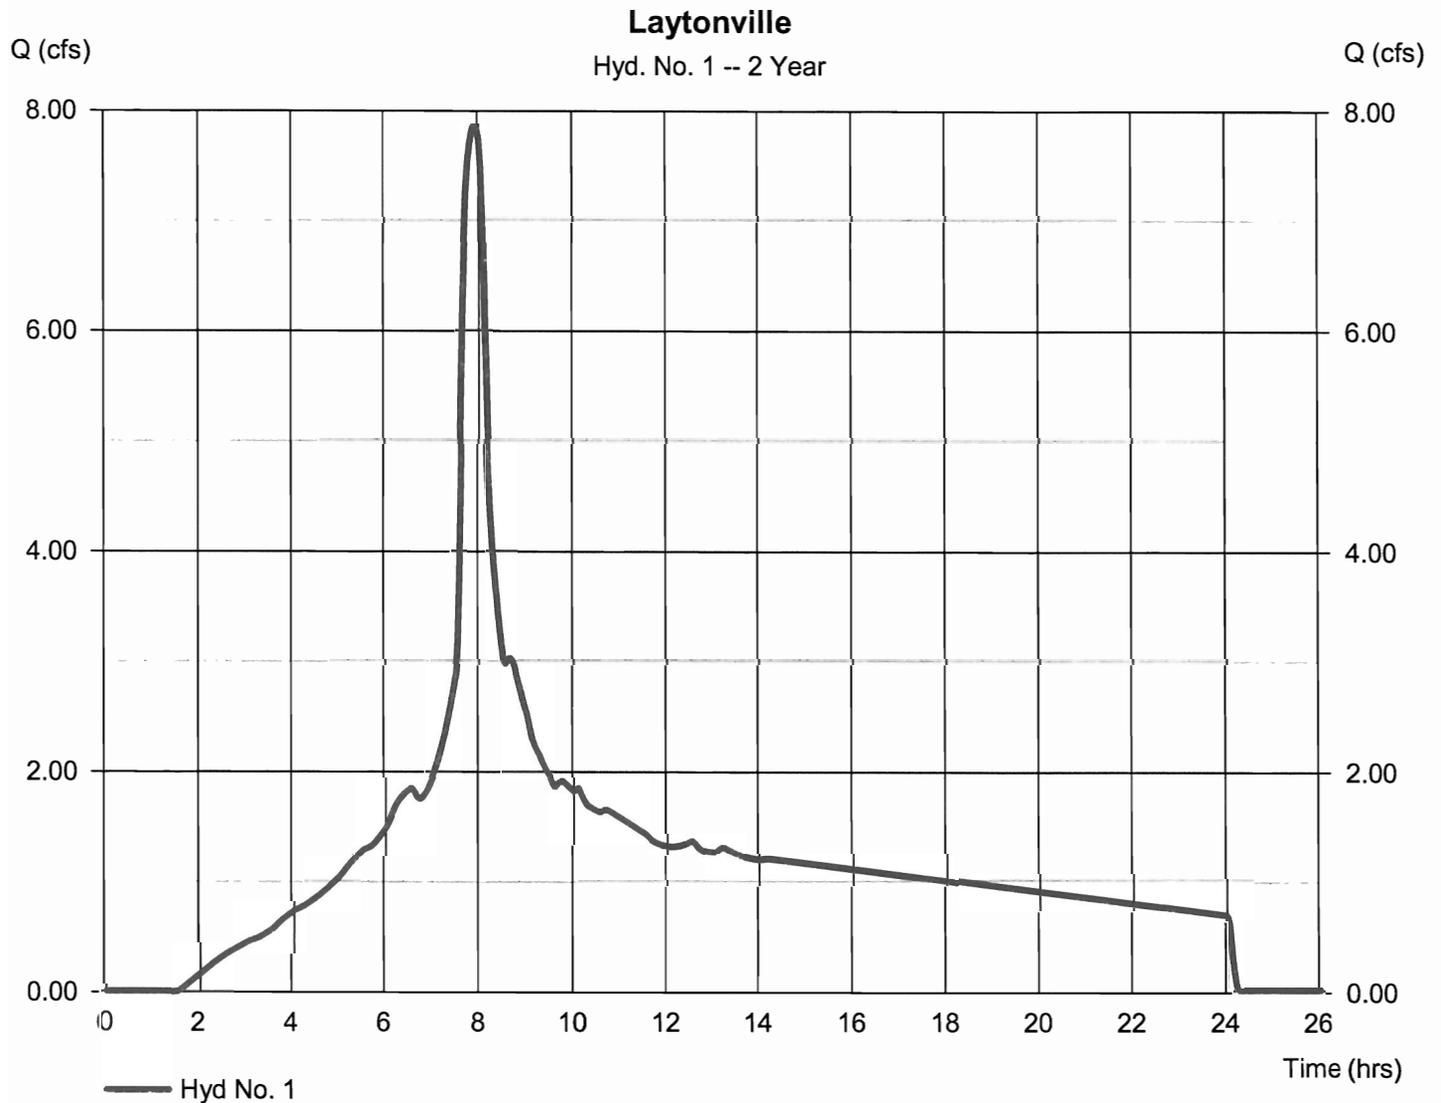
Hydrograph type	= SCS Runoff	Peak discharge	= 7.852 cfs
Storm frequency	= 2 yrs	Time to peak	= 7.92 hrs
Time interval	= 1 min	Hyd. volume	= 108,901 cuft
Drainage area	= 6.100 ac	Curve number	= 91
Basin Slope	= 0.0 %	Hydraulic length	= 0 ft
Tc method	= User	Time of conc. (Tc)	= 10.00 min
Total precip.	= 5.96 in	Distribution	= Type IA
Storm duration	= 24 hrs	Shape factor	= 484

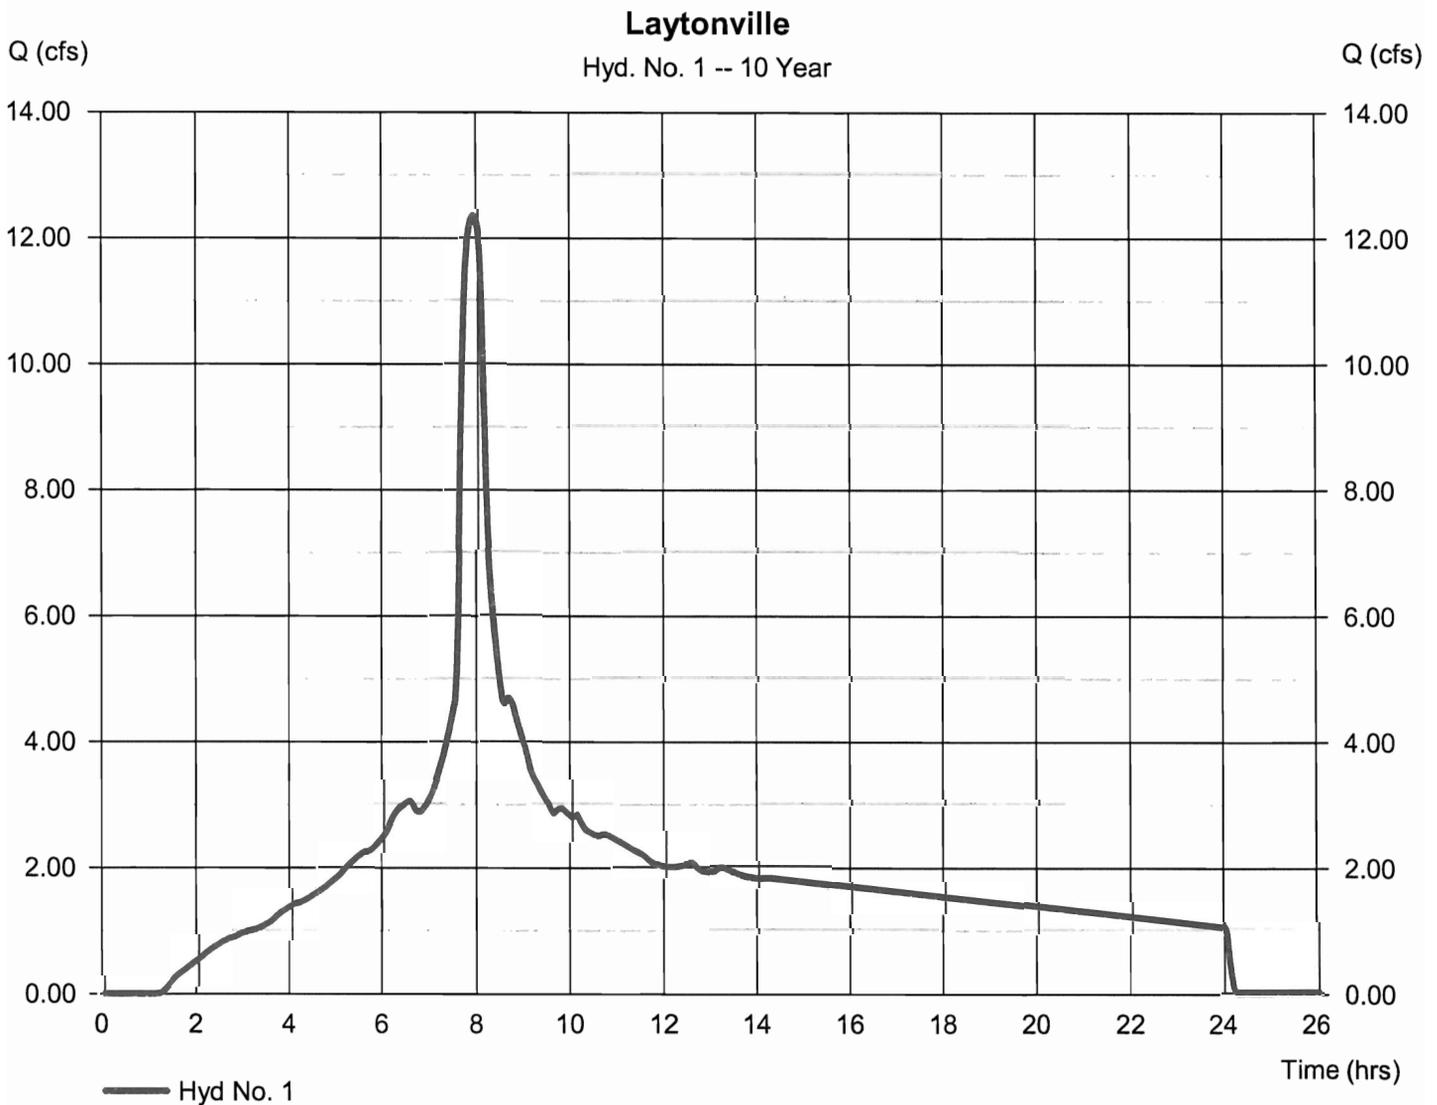
Hydrograph type	= SCS Runoff	Peak discharge	= 12.35 cfs
Storm frequency	= 10 yrs	Time to peak	= 7.90 hrs
Time interval	= 1 min	Hyd. volume	= 172,809 cuft
Drainage area	= 6.100 ac	Curve number	= 91
Basin Slope	= 0.0 %	Hydraulic length	= 0 ft
Tc method	= User	Time of conc. (Tc)	= 10.00 min
Total precip.	= 8.89 in	Distribution	= Type IA
Storm duration	= 24 hrs	Shape factor	= 484

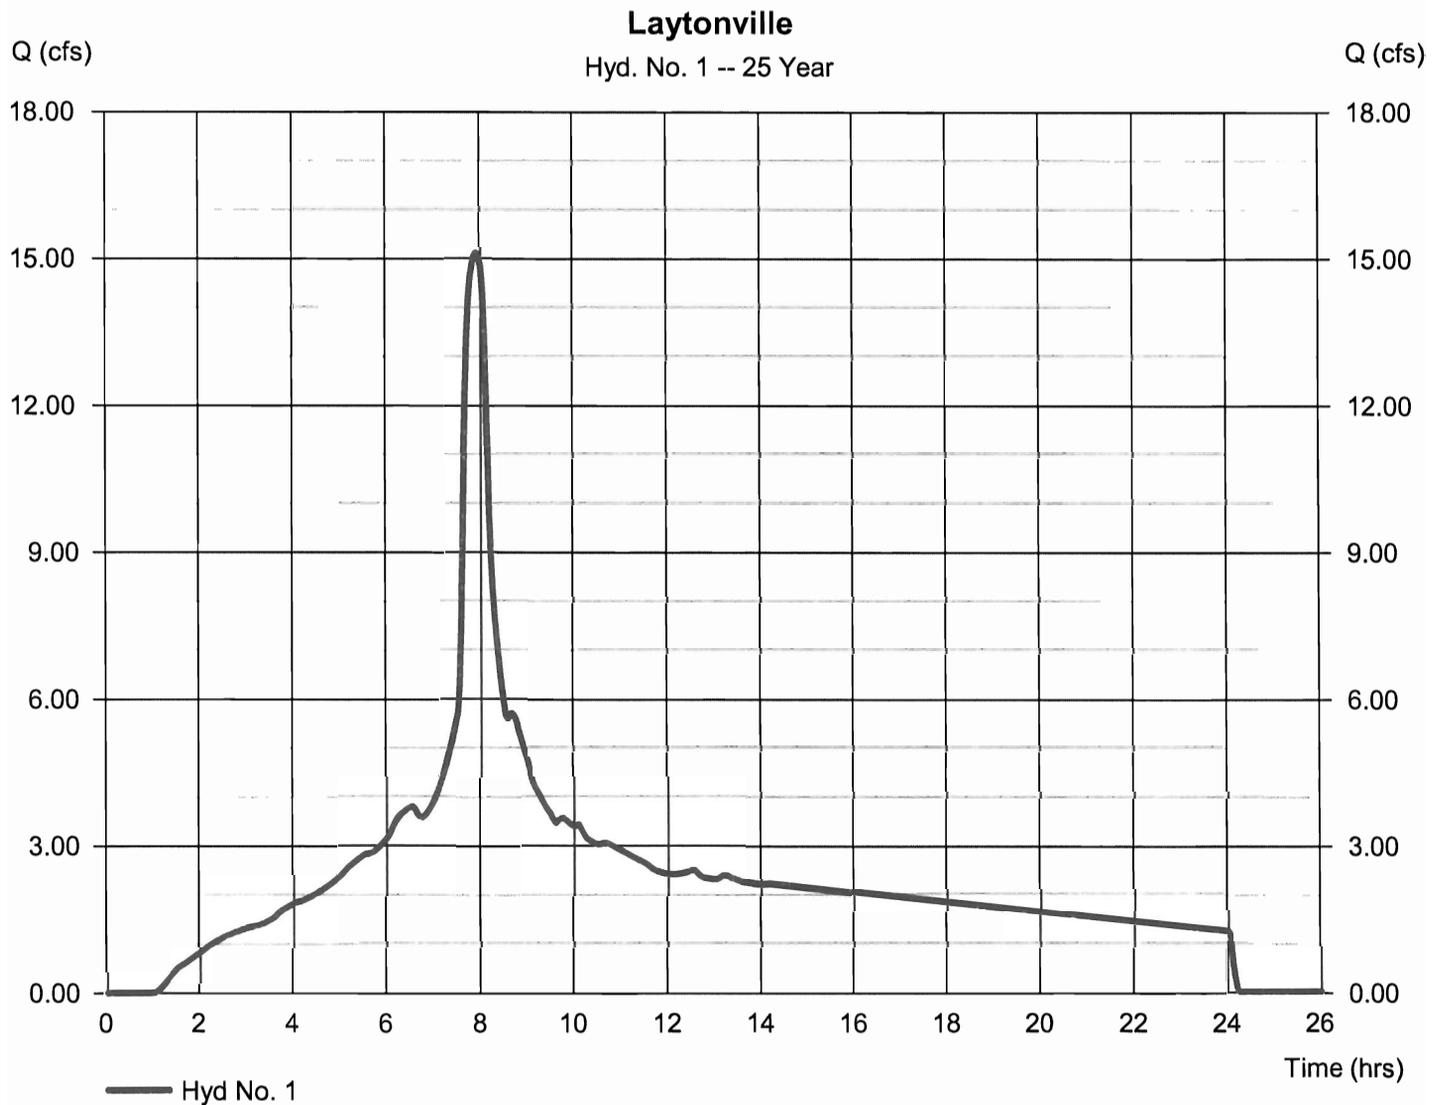
Hydrograph type	= SCS Runoff	Peak discharge	= 15.11 cfs
Storm frequency	= 25 yrs	Time to peak	= 7.90 hrs
Time interval	= 1 min	Hyd. volume	= 212,535 cuft
Drainage area	= 6.100 ac	Curve number	= 91
Basin Slope	= 0.0 %	Hydraulic length	= 0 ft
Tc method	= User	Time of conc. (Tc)	= 10.00 min
Total precip.	= 10.70 in	Distribution	= Type IA
Storm duration	= 24 hrs	Shape factor	= 484

Q<sub>25</sub> = 212,535 CF

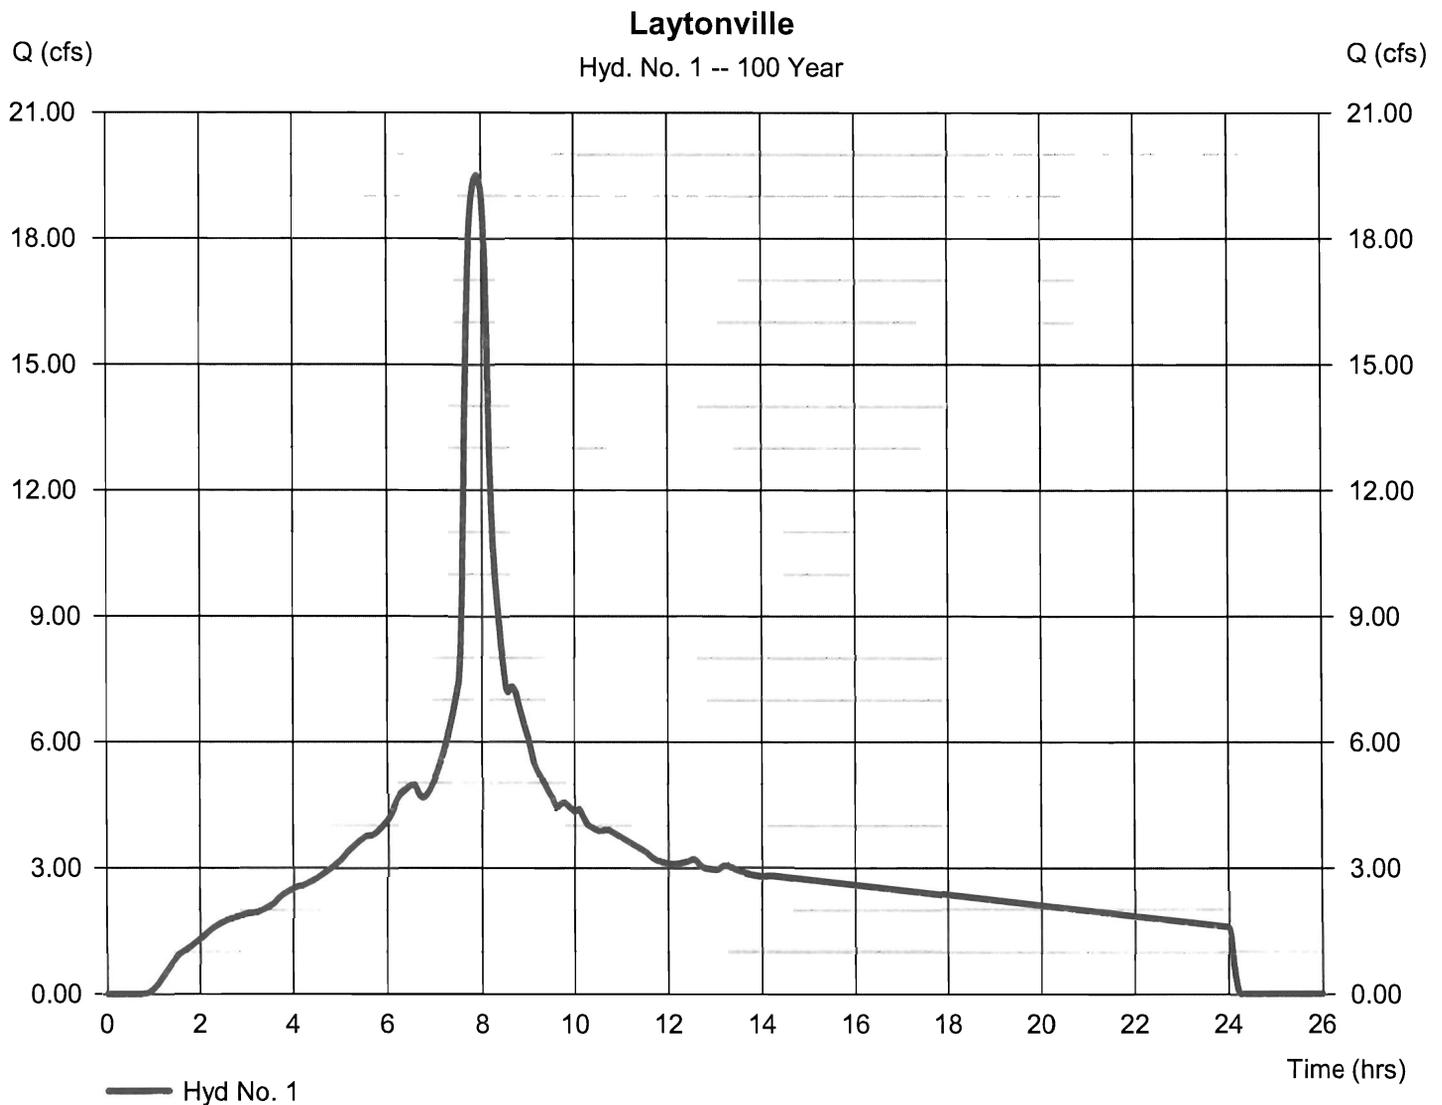
Hydrograph type	= SCS Runoff	Peak discharge	= 19.49 cfs
Storm frequency	= 100 yrs	Time to peak	= 7.90 hrs
Time interval	= 1 min	Hyd. volume	= 276,370 cuft
Drainage area	= 6.100 ac	Curve number	= 91
Basin Slope	= 0.0 %	Hydraulic length	= 0 ft
Tc method	= User	Time of conc. (Tc)	= 10.00 min
Total precip.	= 13.60 in	Distribution	= Type IA
Storm duration	= 24 hrs	Shape factor	= 484

Q<sub>100</sub> = 276,370 CF

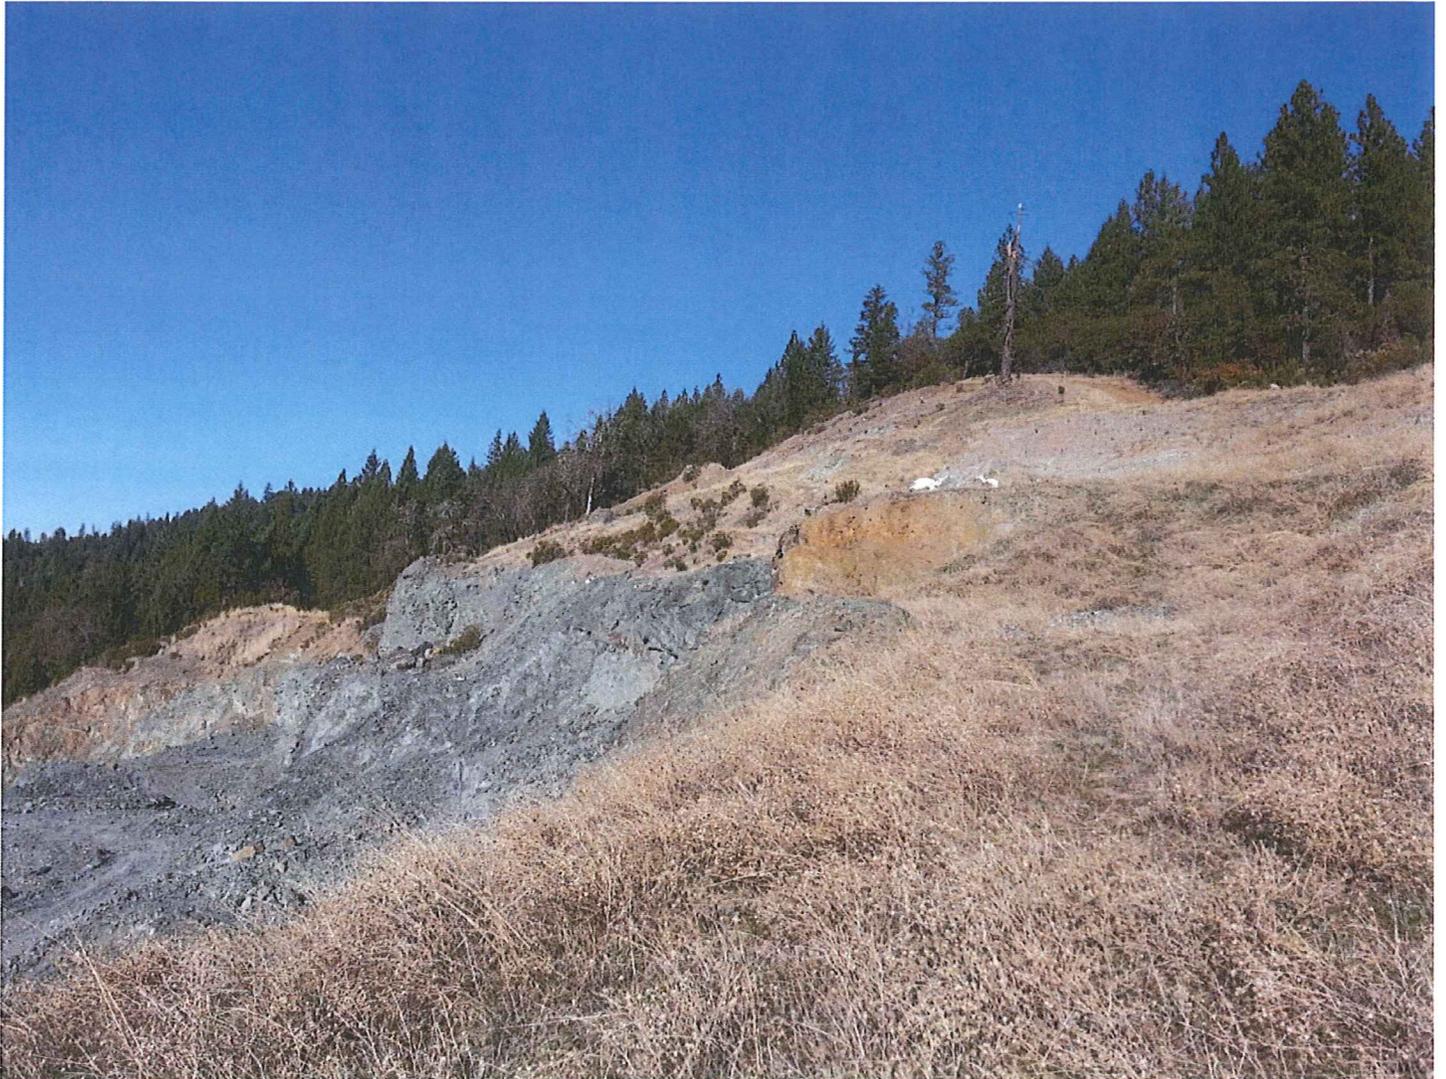
**Photo #1.**

This photograph looks north from an equipment road showing the area of quarrying expansion. Much of this land is barren or covered in grasses and star thistle with a few coyote brush plants and pine seedlings.

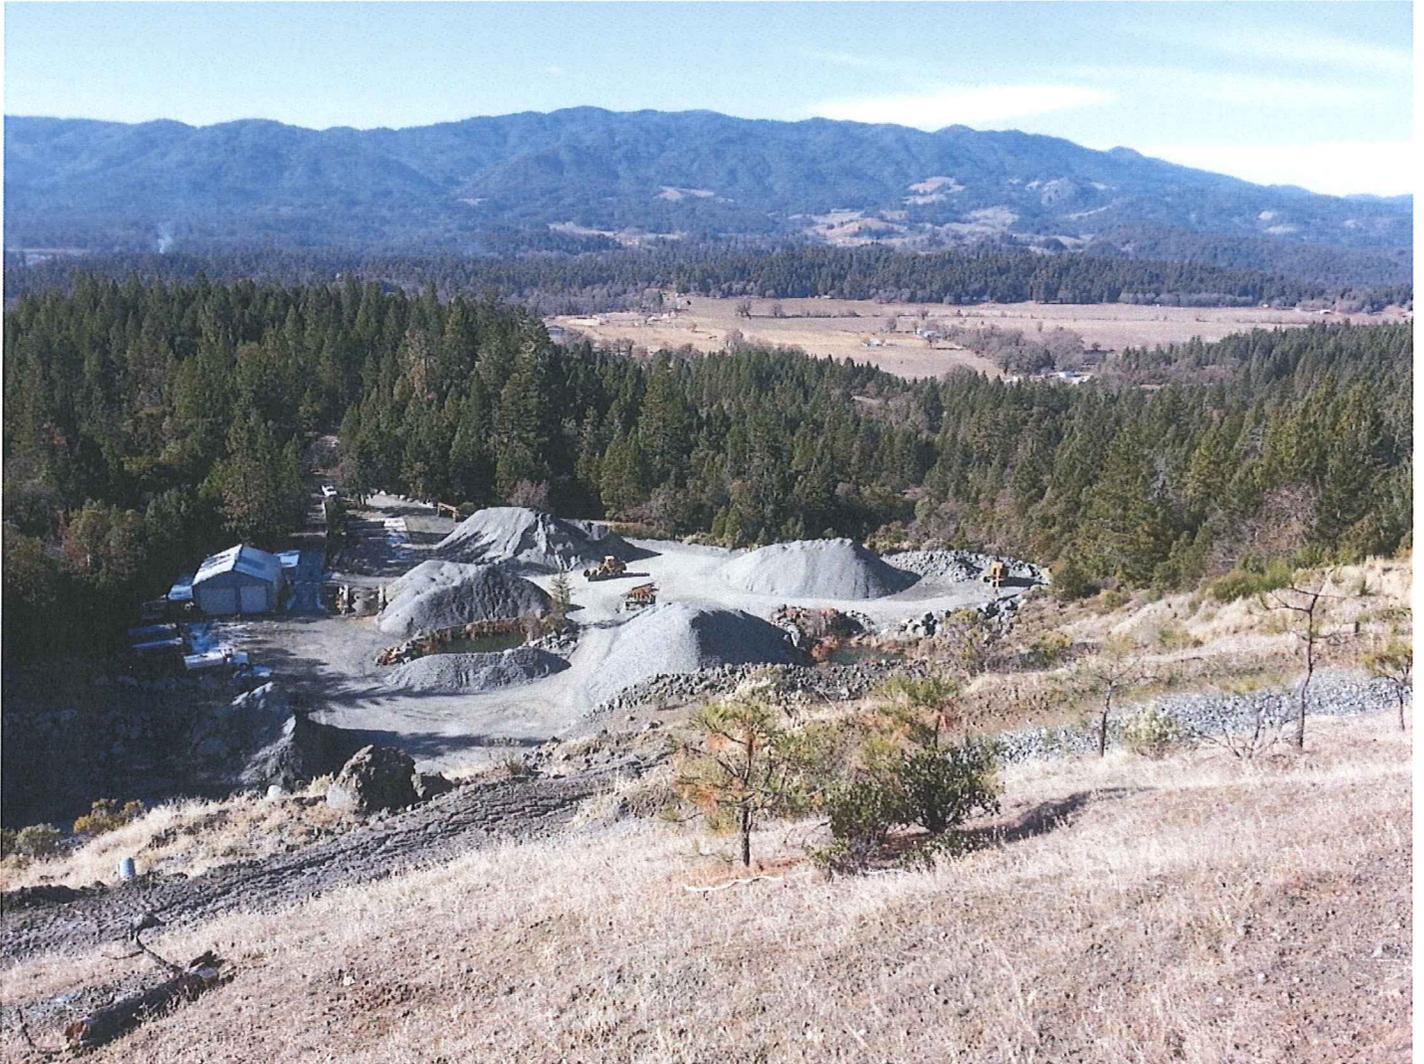
**Photo #2.**

This photograph looks west from the upper area of the proposed quarry expansion. The photo shows the typical quarrying activity. Two settling ponds are visible in the photo.

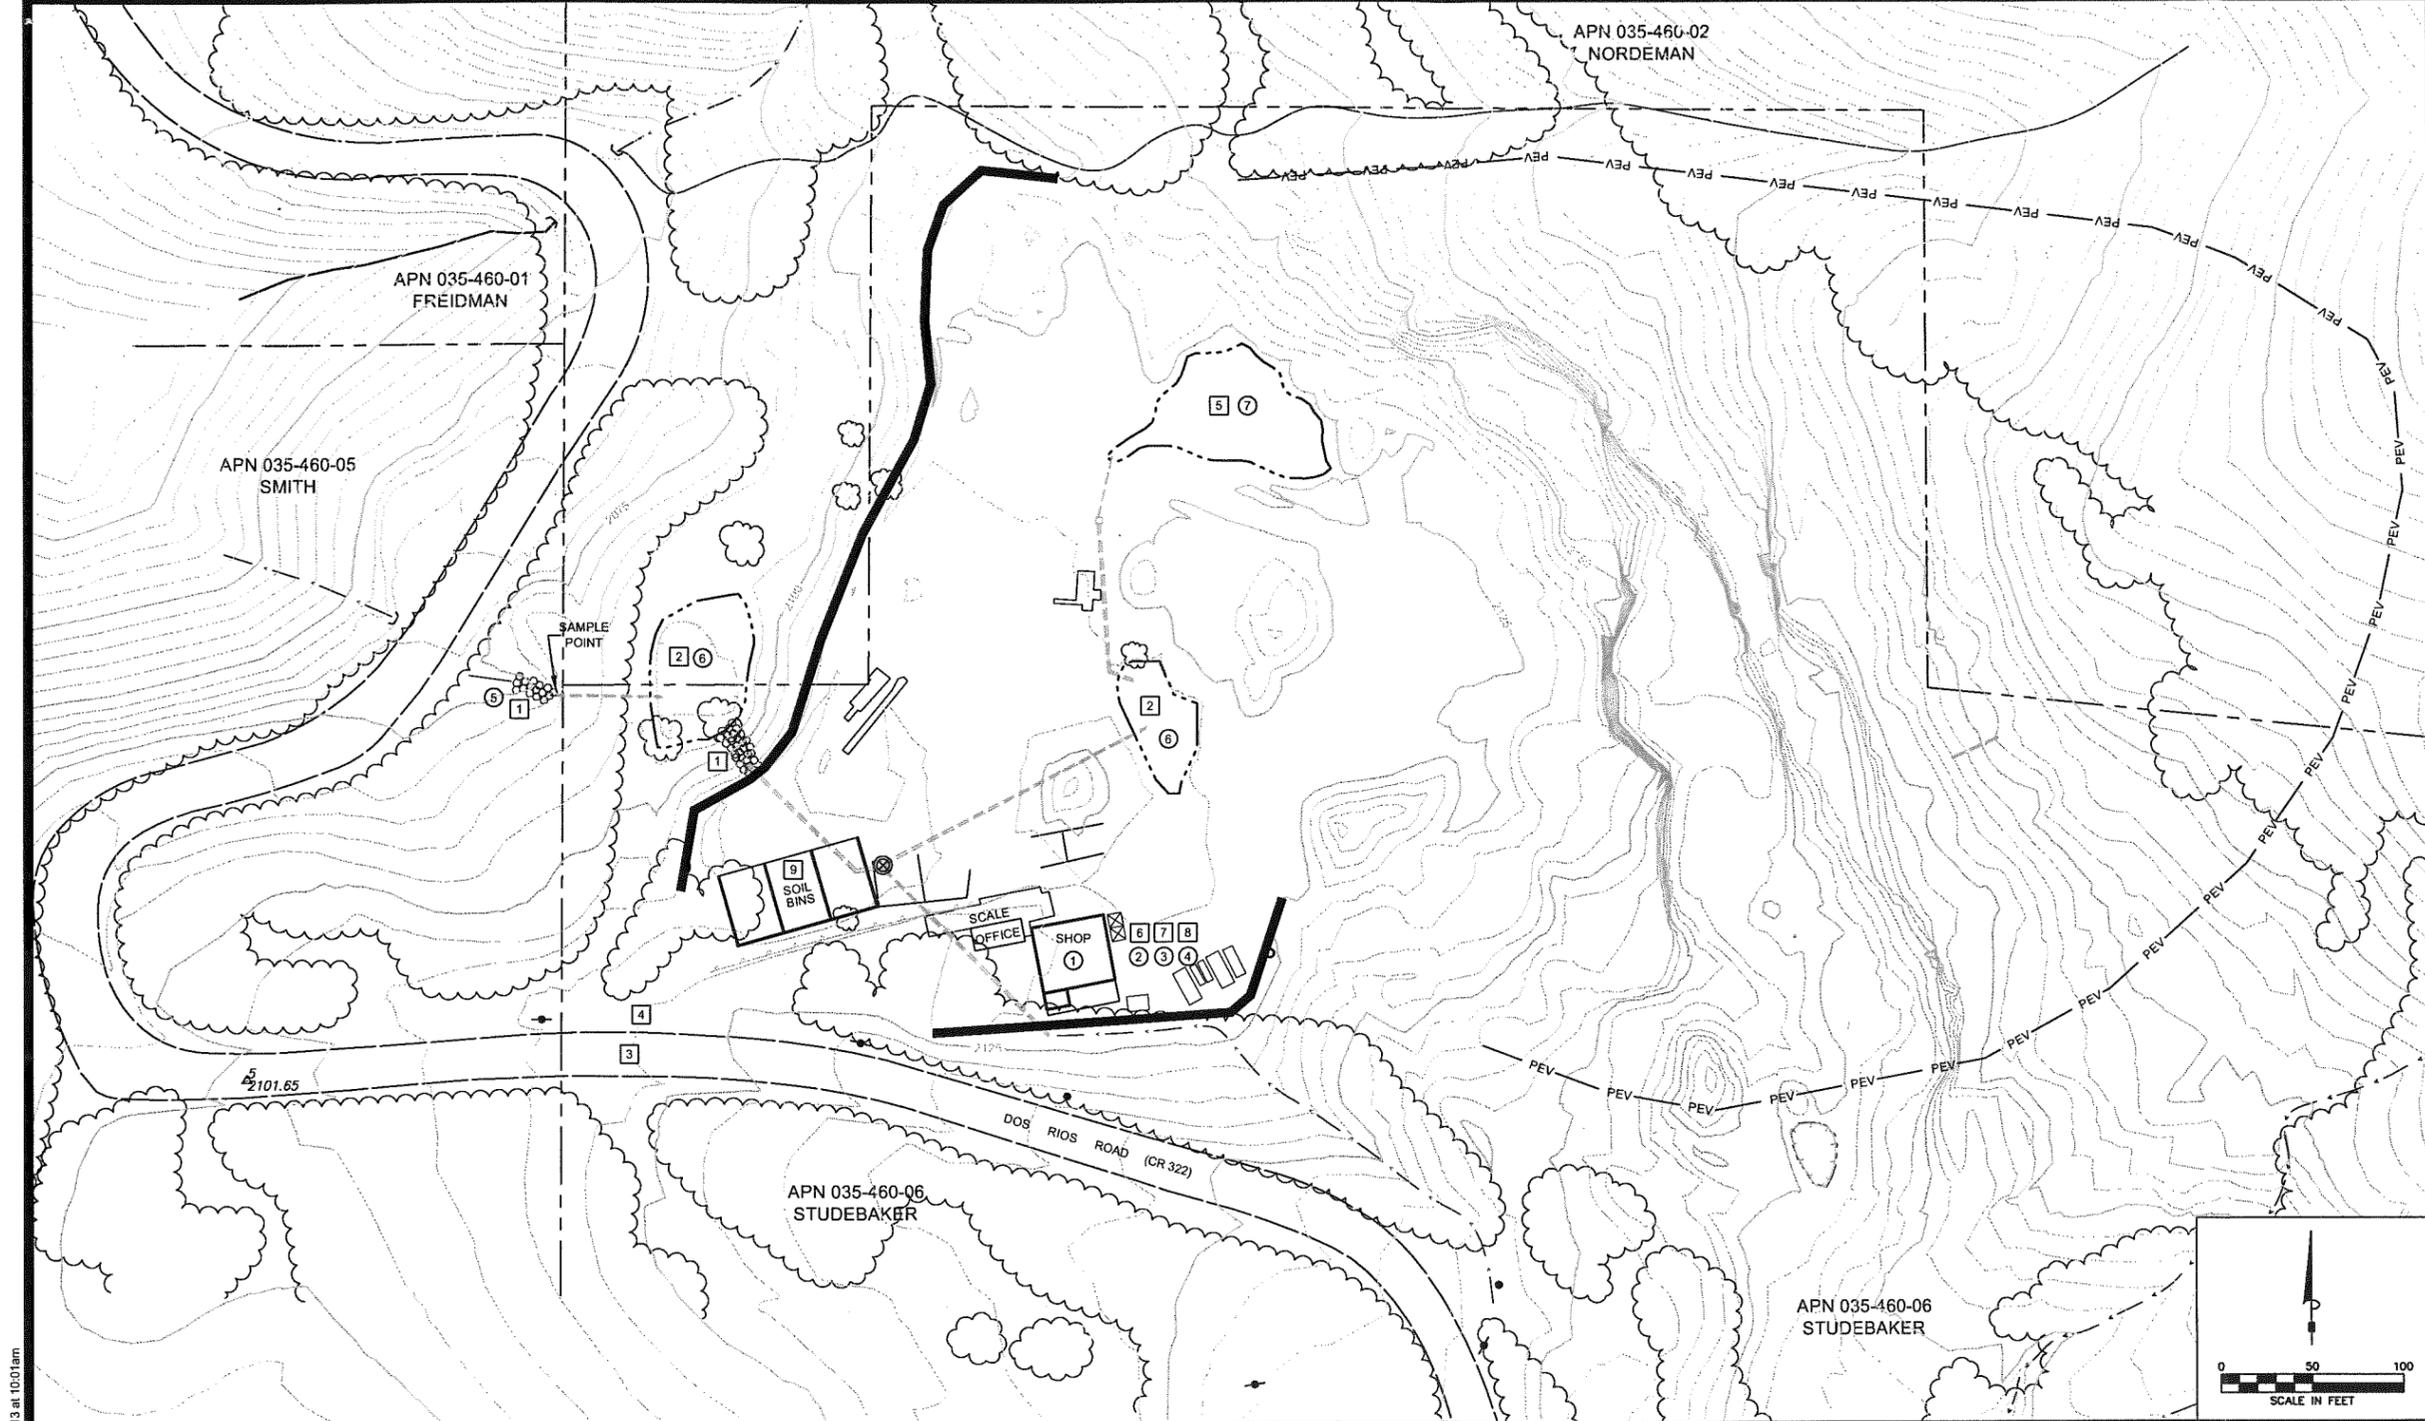
Industrial Facility Type Best Management Practices (BMPs) to be implemented. Refer to BMP Fact Sheets provided in the SWPPP prepared for this facility.		
Location or Symbol	Source & Treatment Control BMPs	
		Non-Stormwater Management
Entire Site	SC-10	Non-Stormwater Discharges
①	SC-11	Spill Prevention, Control and Cleanup
	Vehicle and Equipment Management	
②	SC-20	Vehicle and Equipment Fueling
③	SC-21	Vehicle and Equipment Cleaning
④	SC-22	Vehicle and Equipment Repair
	Material and Waste Management	
Entire Site	SC-30	Outdoor Loading/Unloading
Entire Site	SC-31	Outdoor Liquid Container Storage
Entire Site	SC-32	Outdoor Equipment Operations
Entire Site	SC-33	Outdoor Storage of Raw Materials
Entire Site	SC-34	Waste Handling and Disposal
Entire Site	SC-35	Safer Alternative Products
	Buildings and Grounds Management	
⑤	SC-40	Contaminated or Erodible Areas
Entire Site	SC-41	Building and Grounds Maintenance
Entire Site	SC-42	Building Repair and Construction

Entire Site	SC-43	Parking/Storage Area Maintenance
⑥	SC-44	Drainage System Maintenance
	Treatment Control	
Entire Site	TC-11	Infiltration Basin
⑦	TC-22	Extended Detention Basin
