ATTACHMENT A

MINING AND RECLAMATION PLAN LAYTONVILLE ROCK 1136 LAYTONVILLE DOS RIOS ROAD LAYTONVILLE, CA

RAU AND ASSOCIATES INC.
CIVIL ENGINEERS · LAND SURVEYORS
100 NORTH PINE STREET · (707) 462-6536 · UKIAH, CA 95482

AUGUST 2014
UR # 15-92/13

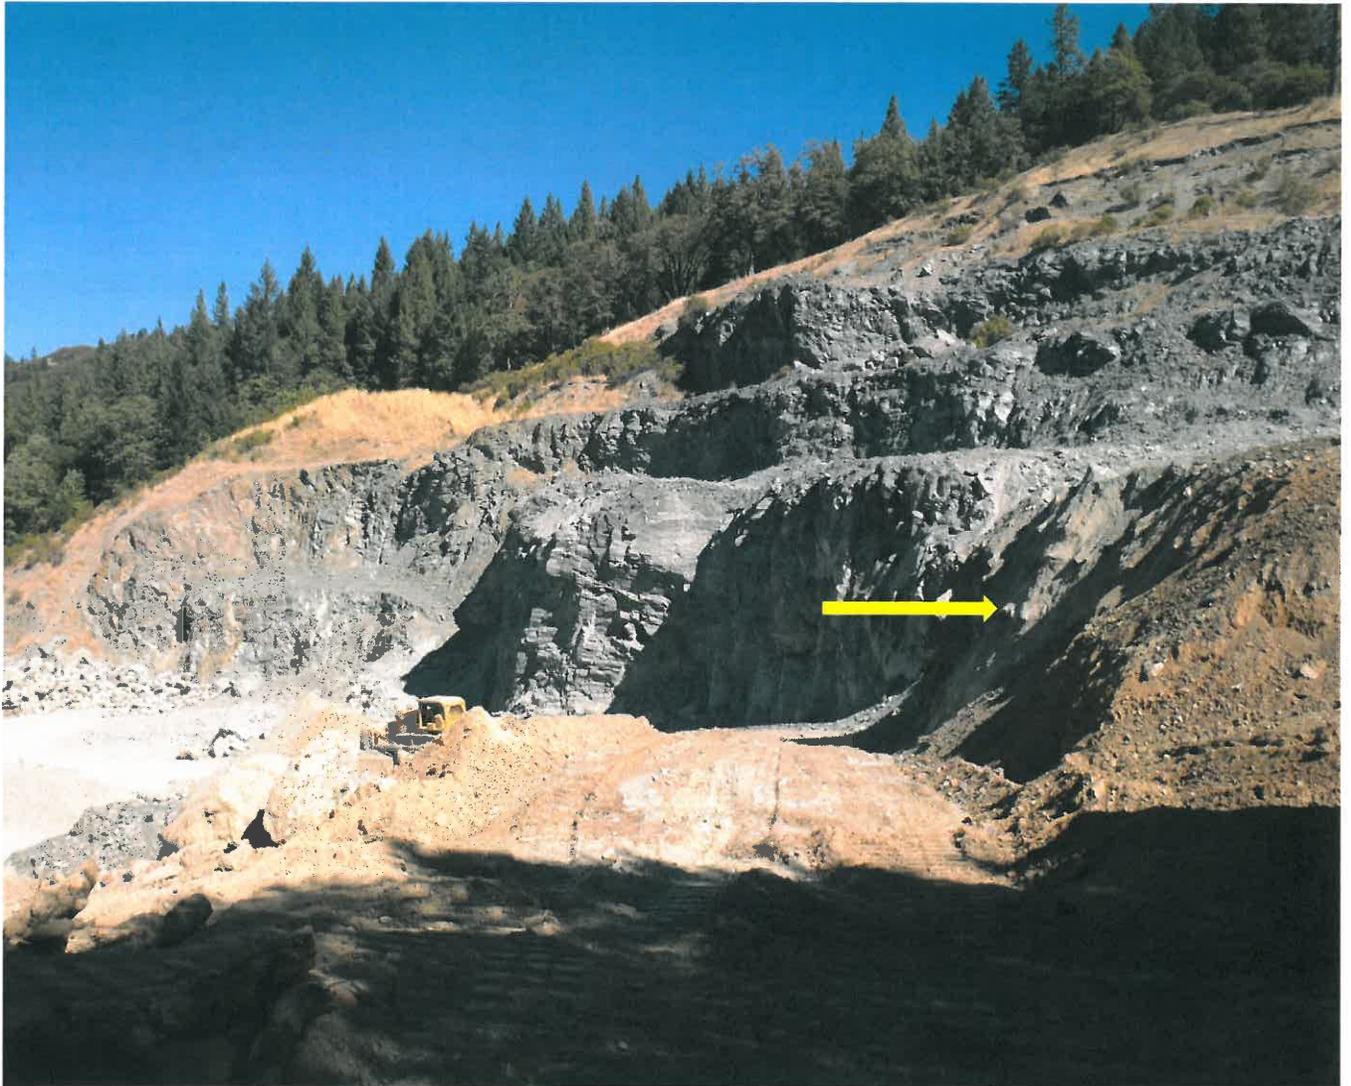
Photograph 1: View looking north along lower quarry working face. Shear zone containing NOA is located in center right of photo denoted by arrow and light brownish gray material.

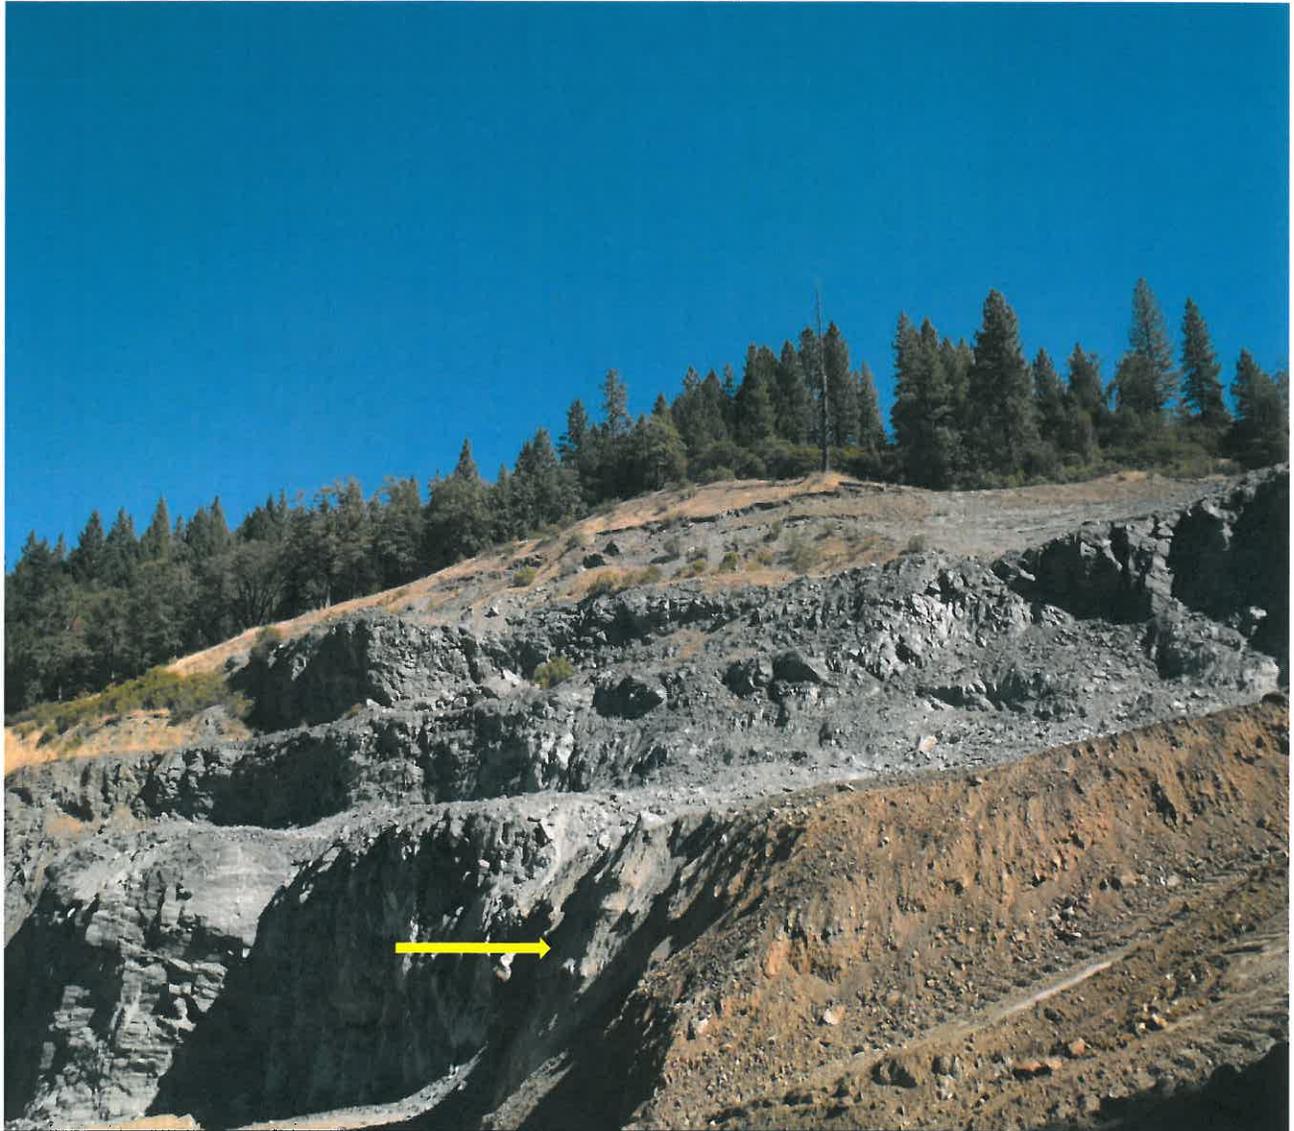
Photograph 2: View looking north along lower quarry working face with close-up view of shear zone containing NOA denoted by arrow and light brownish gray material.
