DATE: May 2, 2016  
TO: Mendocino Historical Review Board  
FROM: Planning and Building Services  
SUBJECT: MHRB 2016-0005 St John, Install Solar Collectors

**MENDOCINO HISTORICAL REVIEW BOARD  
STAFF REPORT**

**PROJECT DESCRIPTION:** A request for a Mendocino Historical Review Board Permit to install solar collectors on the south-facing roof of an existing house.

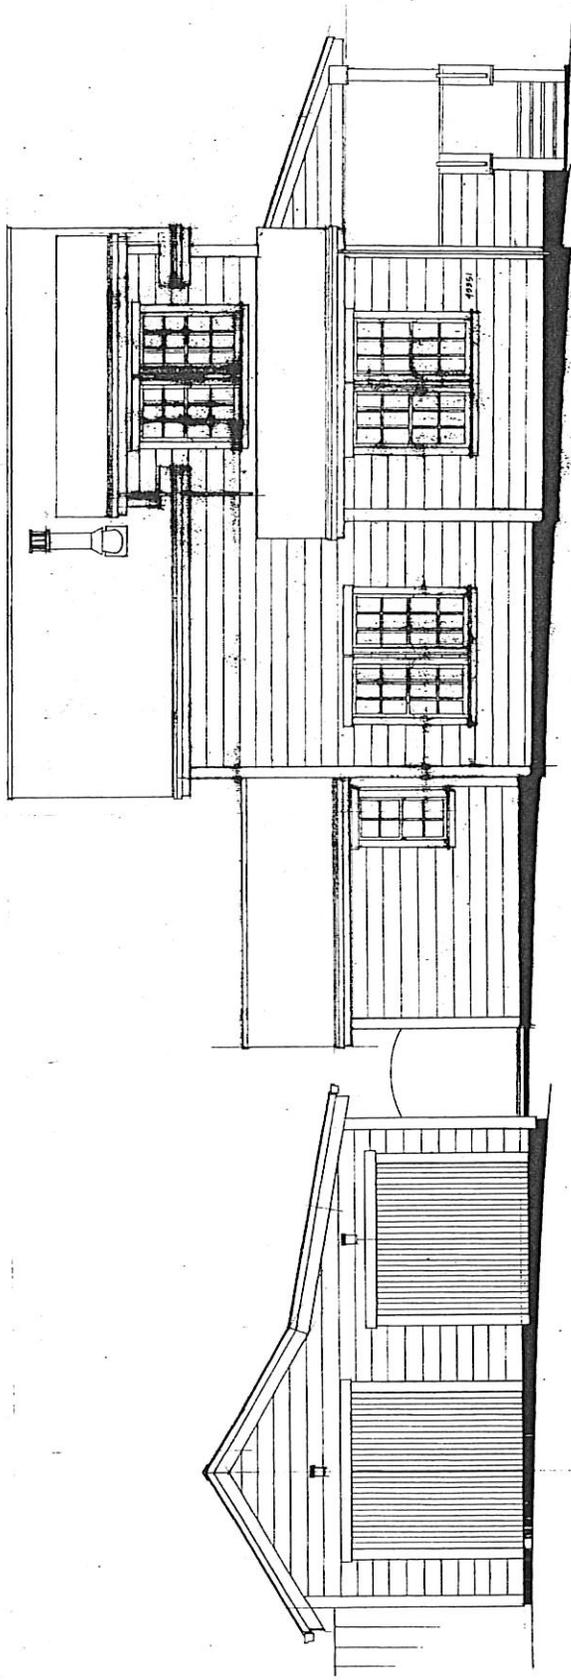
PROJECT TITLE: \_\_\_\_\_  
 NORTH EXTERIOR ELEVATION  
 SCALE: 3/8" = 1'-0" DRAWING # 1016-10-10

NORTH ELEVATION - CAPECOD STREET - PROPOSED - 2016 - 10 - 10  
 SCALE 3/8" = 1'-0"

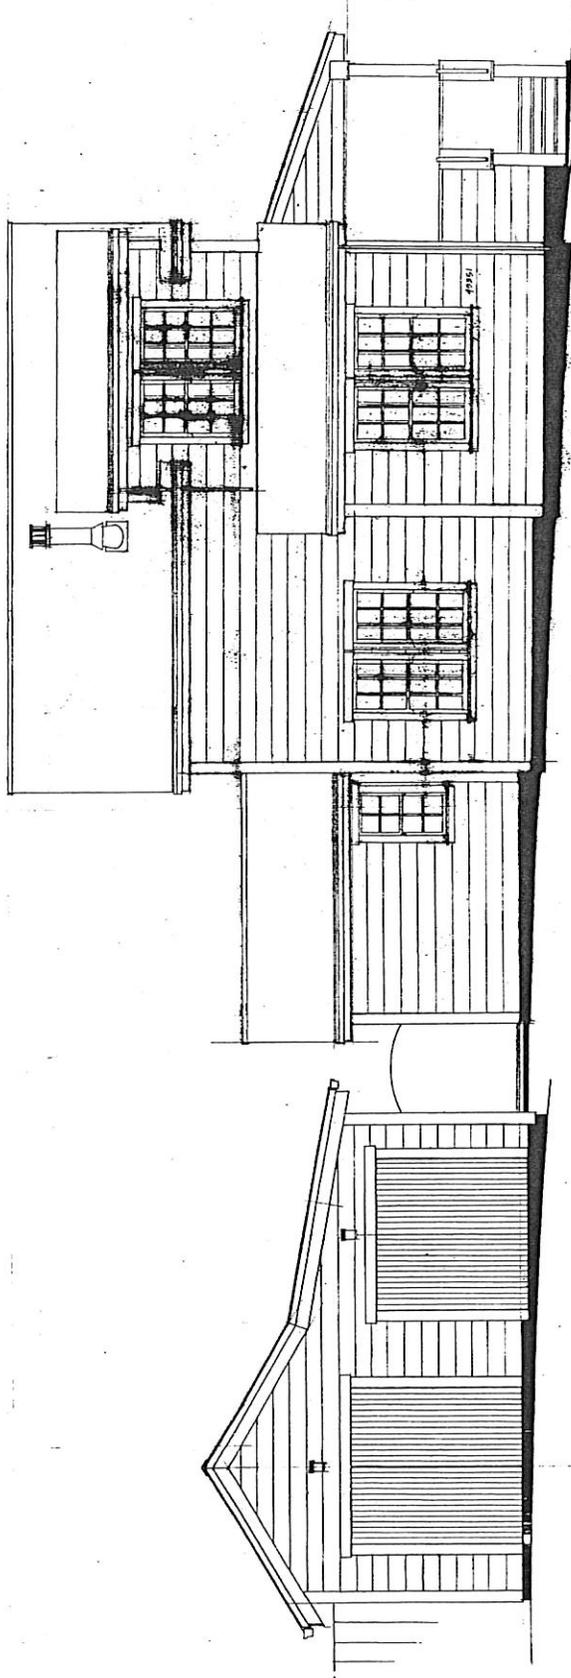
2.  
OF 24 SHEETS

NORTH ELEVATION - CAPELLA STREET - 1/8" = 1'-0"

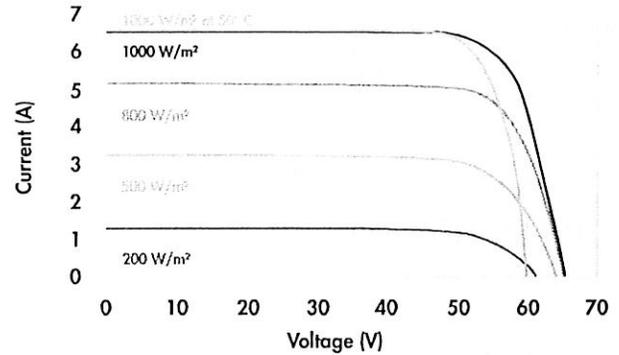
### I-V CURVE

Current/voltage characteristics with dependence on irradiance and module temperature.

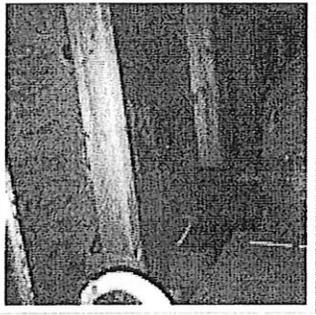
Currently your sub-floor is not insulated. With good access under your house. It would be relatively easy to add this.

Insulating the sub-floor prevents heat and cool loss from the floor, just like walls and ceiling. Crawlspace can be converted from an unconditioned to a conditioned space which includes sealing off any vents to the outside, insulating the foundation walls, and installing a vapor barrier on top of the dirt floor. It often includes adding a jump vent to the main conditioned space in the house or ducting the furnace and/or A/C into the crawlspace as well. While common in many parts of the country, it is not cost justified in CA

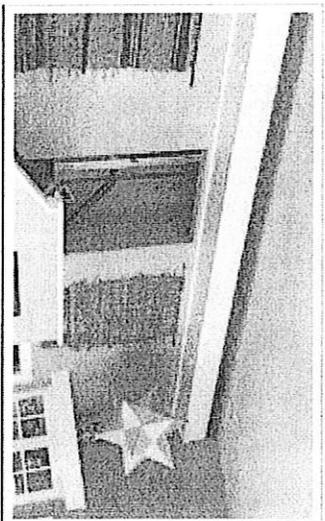
You have many installed lights. They appear to mostly be halogen which are typically low wattage but not considered high efficacy or efficient since they put out a lot of heat. It also appears that you probably don't use all lighting at the same time.

It is smart practice to replace incandescent lighting with high-efficacy type when the incandescents start burning out. With other aspects of energy use becoming more efficient, lighting begins to be a big part of the pie.

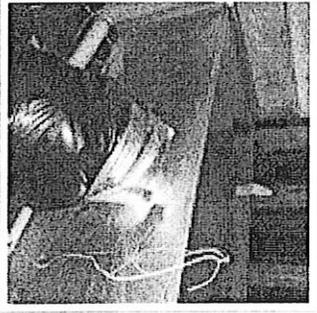
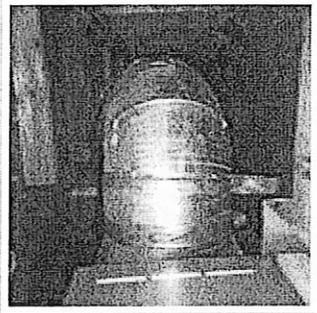
Your ducts are not overly leaky at this time.

While your ducts are not overly leaky, they are showing signs that leakage will increase. Duct tape used to hold the connections is beginning to dry and fall off. Also note that significant evidence of rodents was found. It is not uncommon for these pests to chew through the ducts in search of warmth.

| Details | Now | Goal |
|---|---|---|
| Duct Leakage | 15% - Somewhat leaky | Seal to 6% Leakage |

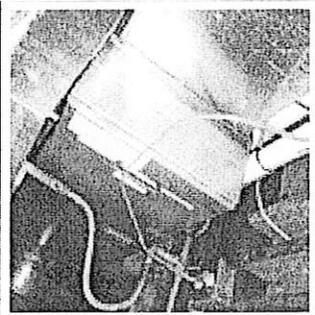
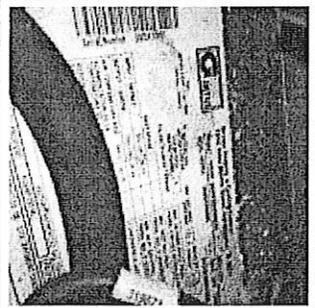
Your furnace is an Energy Star rated high-efficiency sealed combustion model (>90%) and runs on propane.

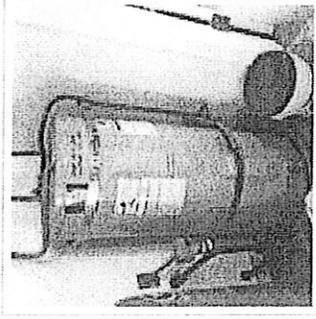
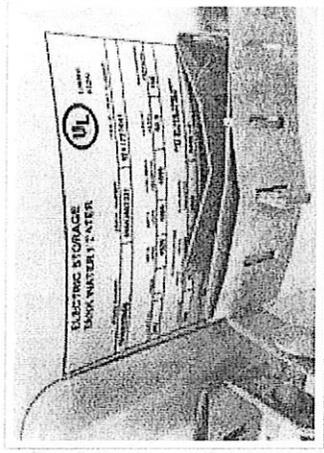
**Notes to Homeowners**  
Your water heater is relatively new and efficient.

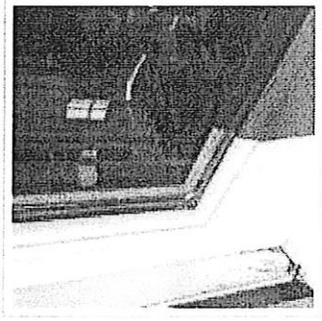
Your windows are fairly energy efficient. They are dual-paned tightly constructed with high R-value material (wood).
