**COUNTY OF MENDOCINO
DEPT. OF PLANNING & BUILDING
SERVICES**

MHRB APPLICATION FORM

We propose to substantially restore and remodel an existing structurally deficient guest cottage at the SE corner of the property. The cottage needs a new foundation; in order to install a foundation the cottage must be shifted a slight amount, as the South and East walls of the cottage are too close to the property lines to allow new footings. The following specific topics also seem relevant:

PROJECT TITLE:
THE RESTORATION and IMPROVEMENT of AN EXISTING OUTBUILDING
 for MR. MICHAEL ST. JOHN

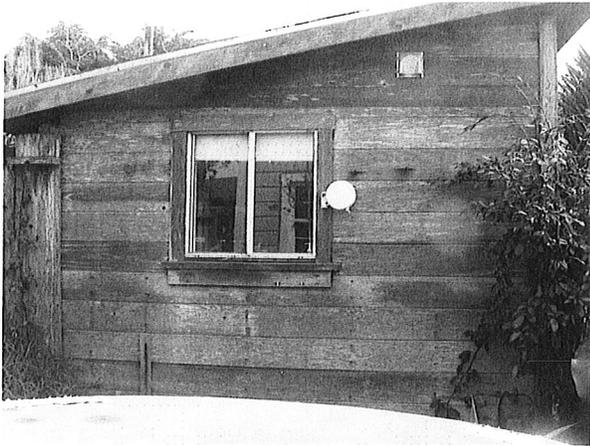
1. Existing North elevation of the guest cottage, showing the aluminum sliding window, and the shallow roof pitch draining East onto the neighbor's property.

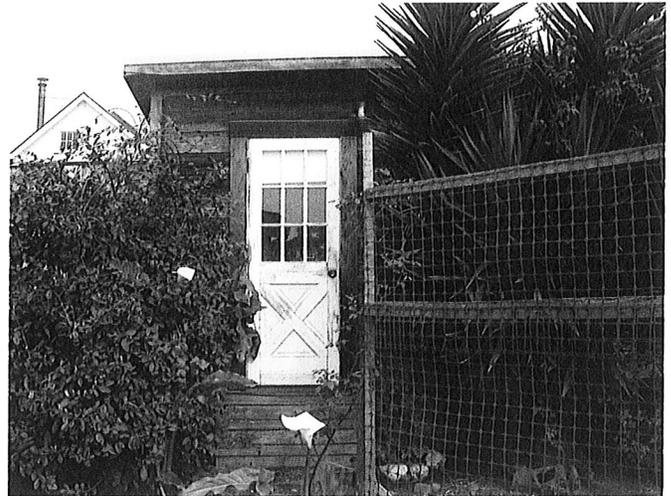
2. Existing door at the North-West corner of the guest cottage. The non-code steps with no landing are visible beyond the calla lily.

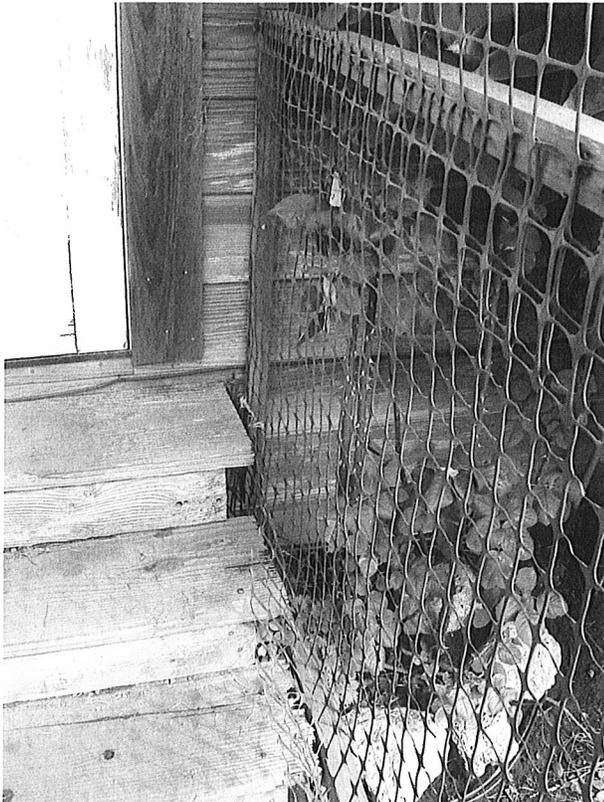
3. The top of the non-code steps. In addition to being non-code, they are weak.

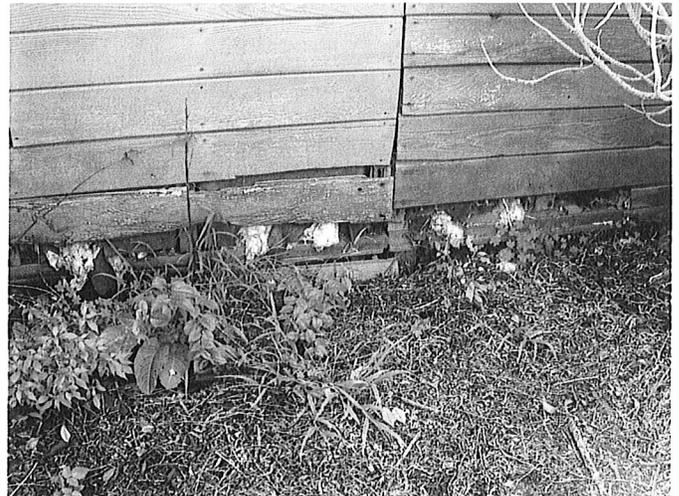
4. The East side of the guest cottage is shown here; visible are: rotten and missing siding, exposed studding, lack of any real foundation, too-high ground level, and a ground slope which drains water right under the building. All these defects will be made good by this project.

- 2. Condition of the existing building:** The existing building is beetle-infested and structurally unsound. It is on piers. There is no perimeter foundation. It is therefore vulnerable to earthquake damage. The framing is irregular (we will save as much of the original framing as we can) and there is little or no shear value to the siding, which is deteriorating badly. In addition the ground level near the building has risen over time & rot has set in to the building's lower parts.

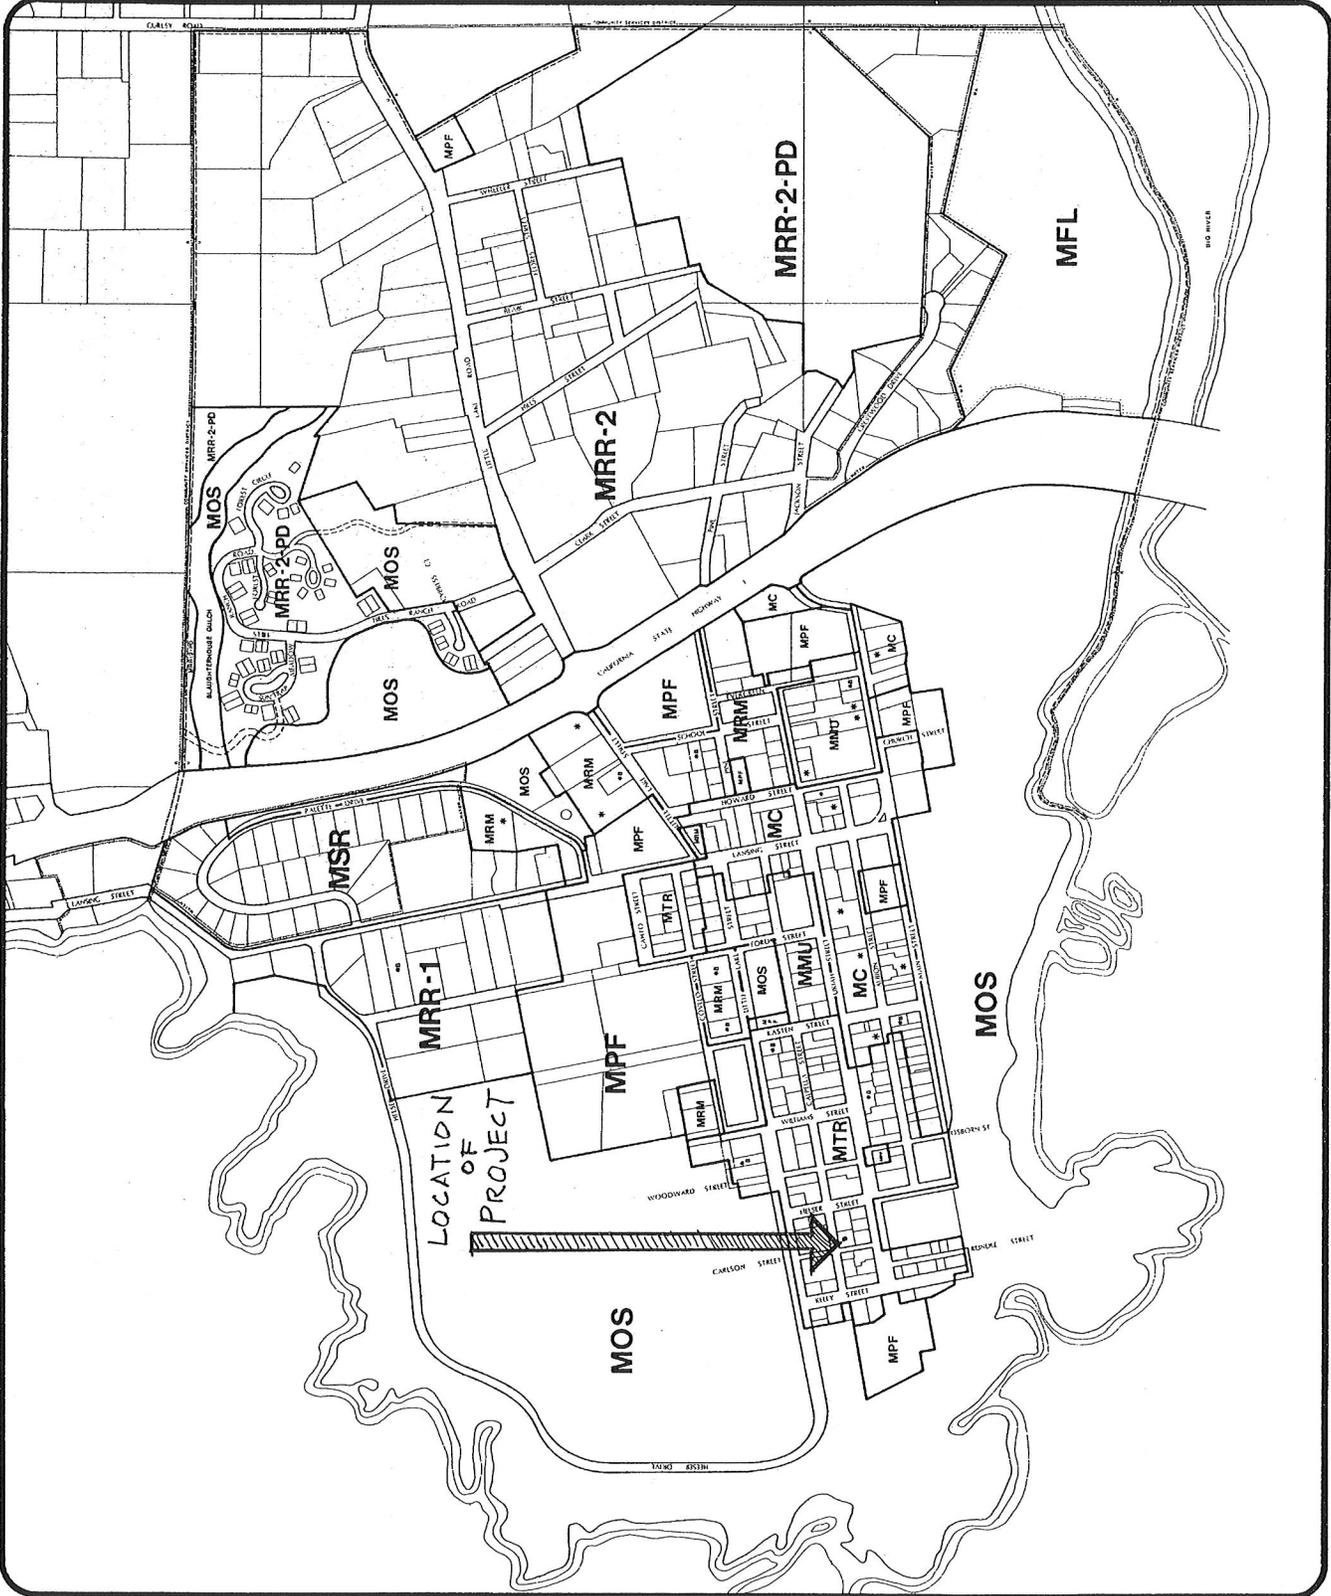
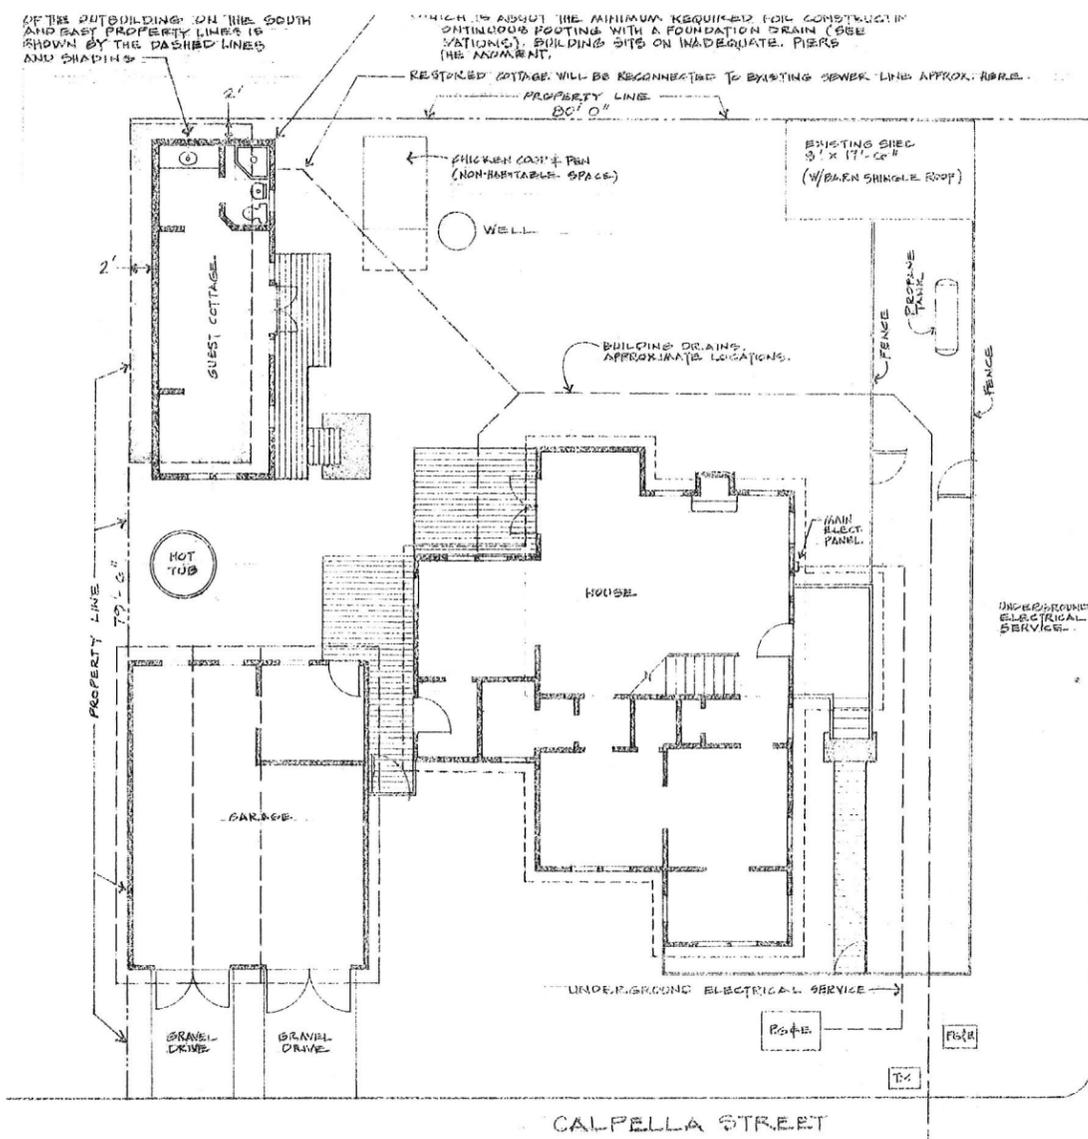
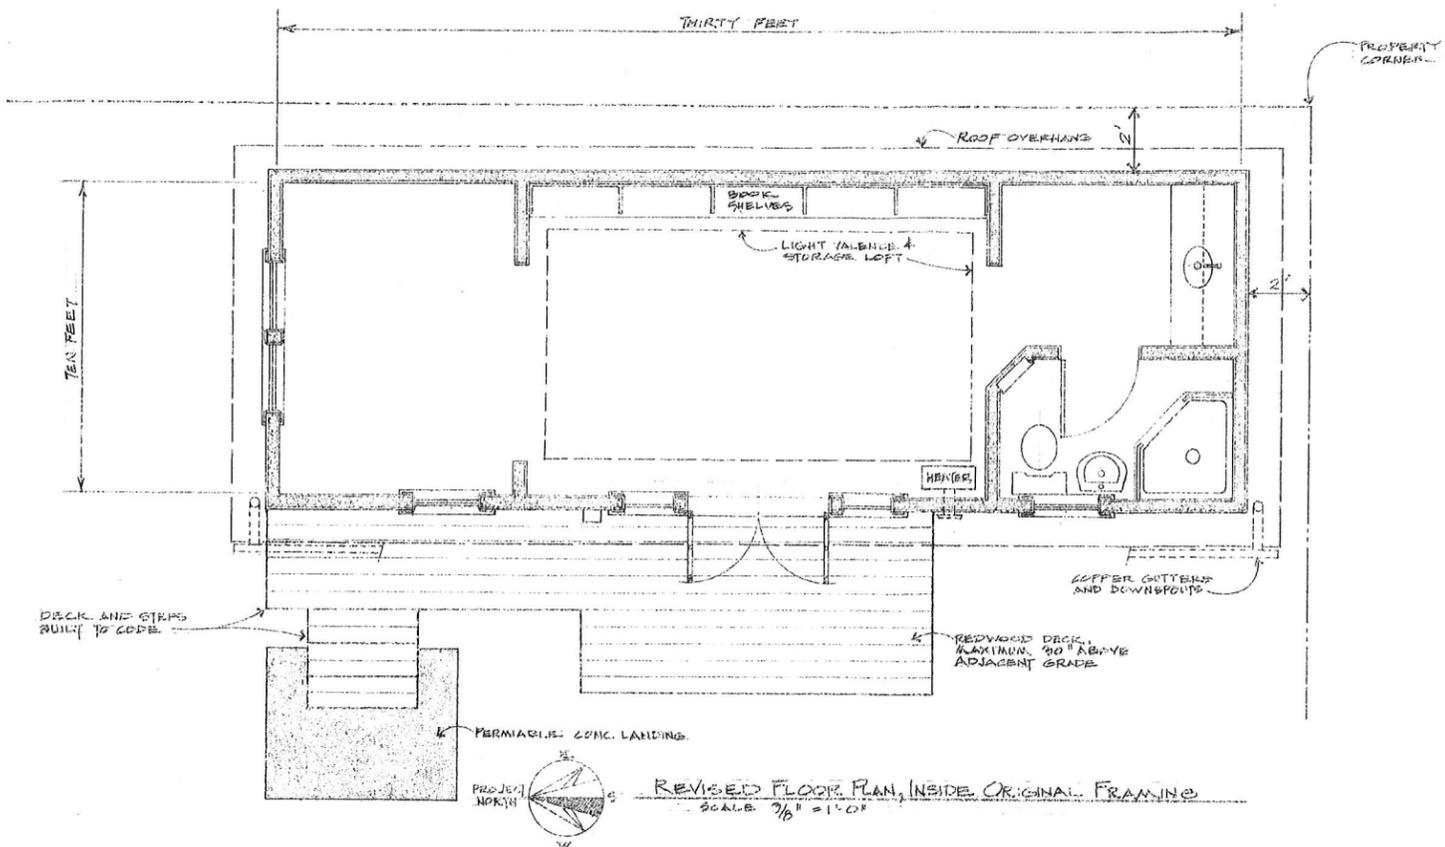
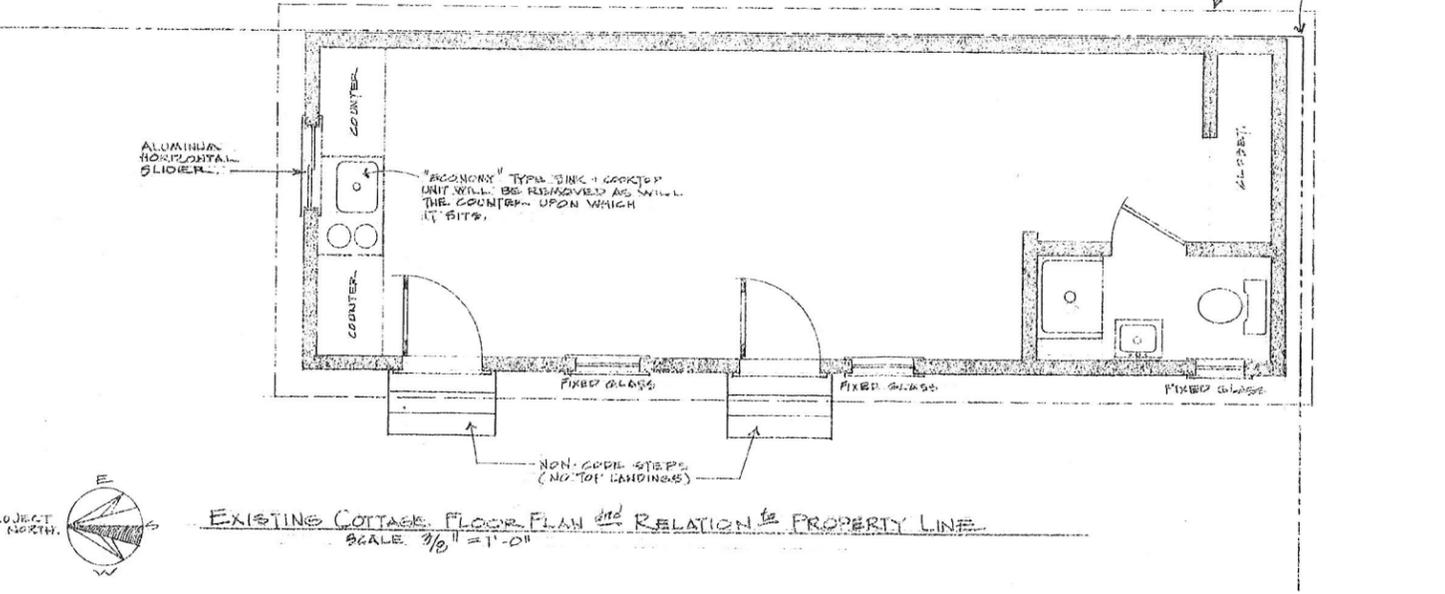
SHEET NUMBER:
 1

SITE PLAN LOT AREA = 6960 SF EXIST. COVERAGE = 37% PROJECT CHANGES NEITHER OF THESE
 SCALE 1/8" = 1'-0"

SHEET TITLE:
 • SITE PLAN
 • REVISED FLOOR PLAN
 • EXISTING FLOOR PLAN

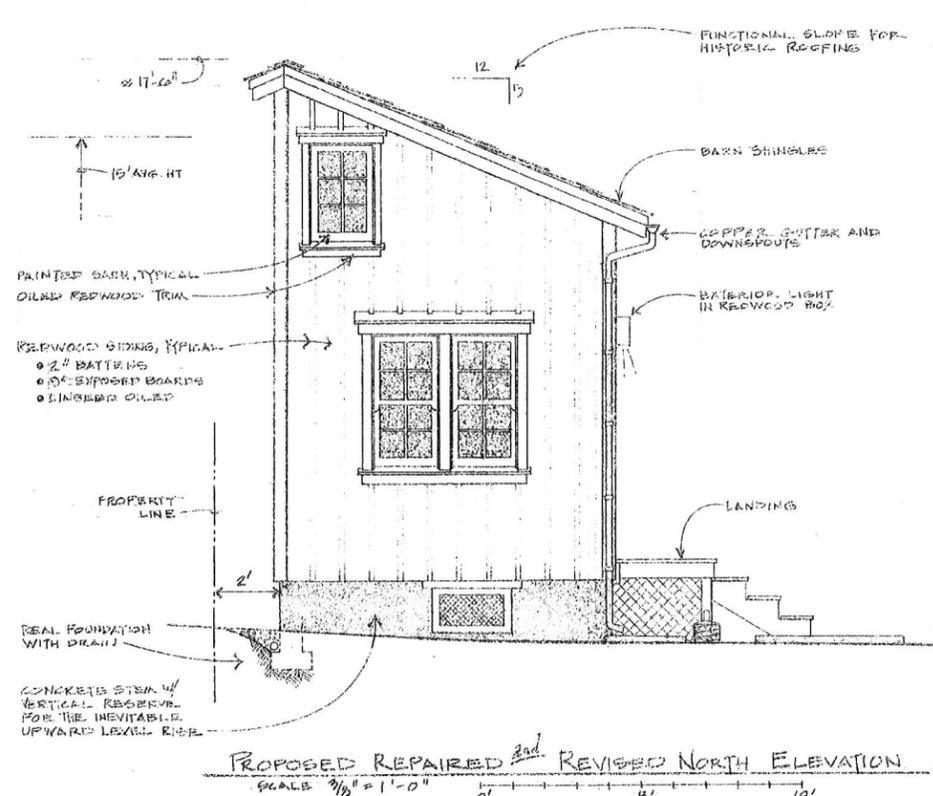
PROPOSED REPAIRED ^{and} REVISED NORTH ELEVATION
SCALE 3/8" = 1'-0"

7. **Siding:** The existing siding is V-grooved "Channel Rustic" popular in the 1950s and 1960s. Much of it is "shot." We propose to use rough-sawn redwood board-and-batten siding and all-redwood trim, finished with linseed oil. The linseed oil will protect the wood yet let it weather to a somewhat dark "natural" appearance. The siding and trim will be milled locally by Anderson's Alternatives.

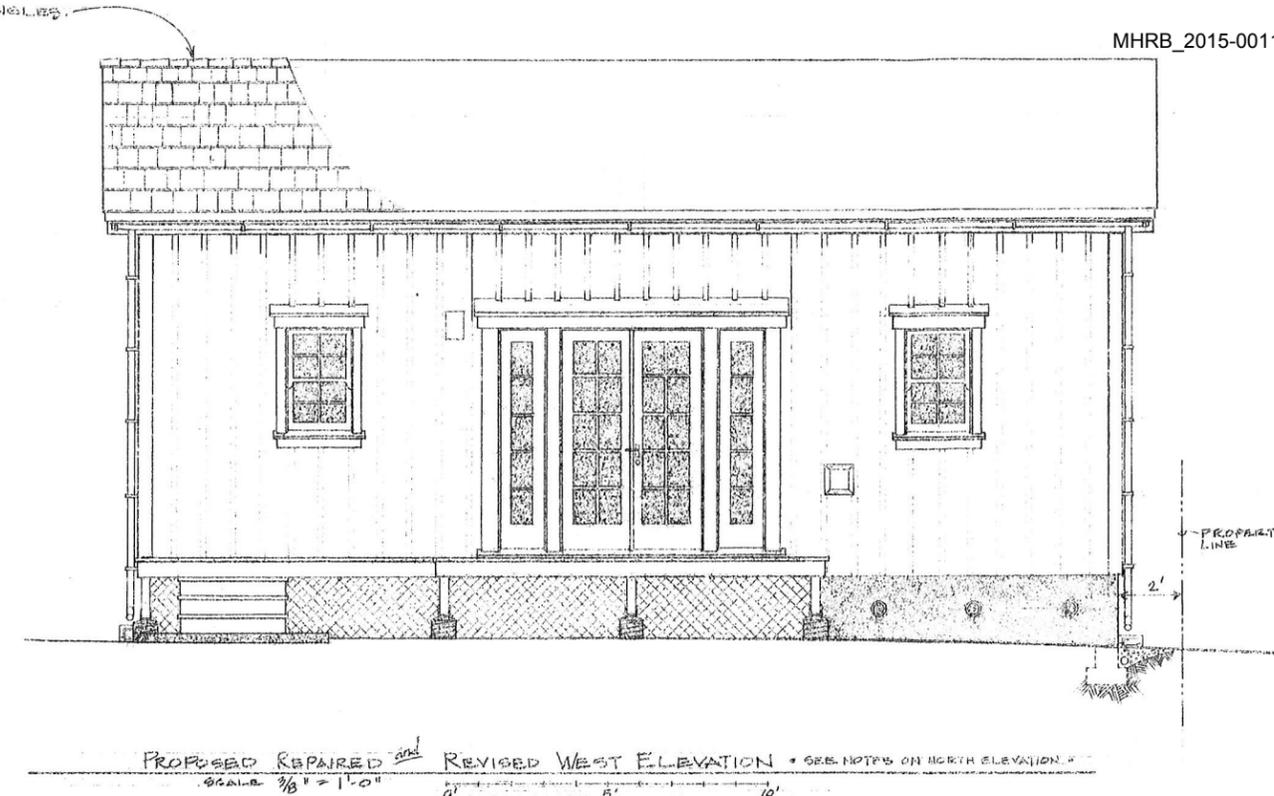
PROPOSED REPAIRED ^{and} REVISED WEST ELEVATION • SEE NOTES ON NORTH ELEVATION •
SCALE 3/8" = 1'-0"

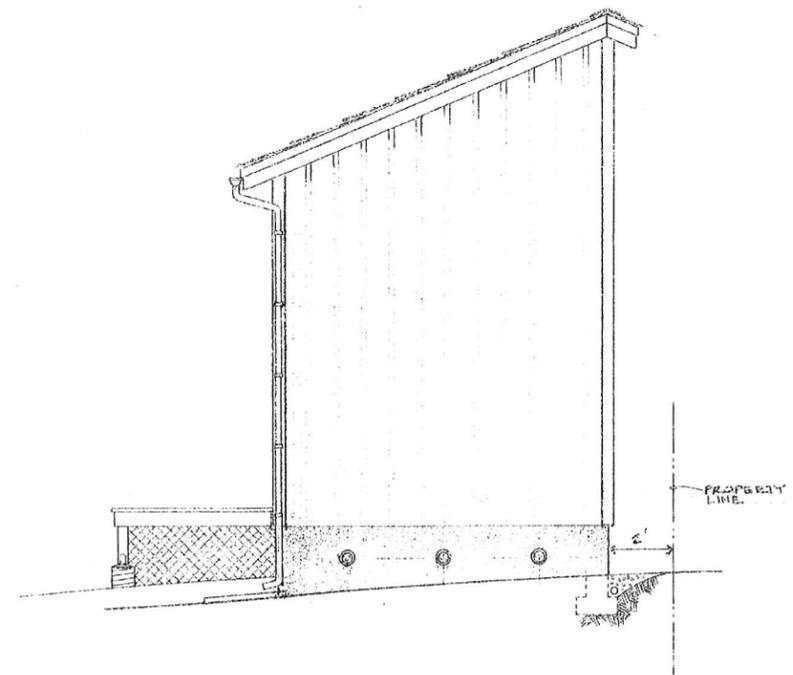
PROPOSED REPAIRED ^{and} REVISED SOUTH ELEVATION
SCALE 3/8" = 1'-0"
• SEE NOTES ON NORTH ELEVATION •

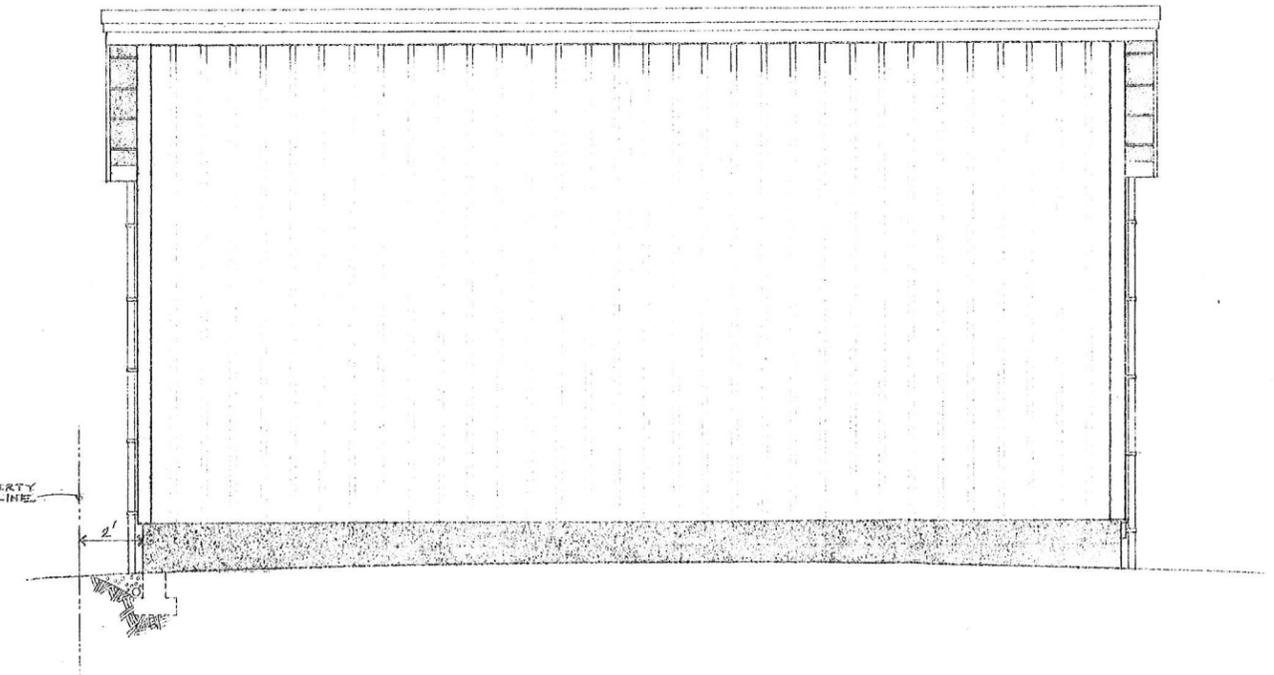
PROPOSED REPAIRED ^{and} REVISED EAST ELEVATION • SEE NOTES ON NORTH ELEVATION •
SCALE 3/8" = 1'-0"

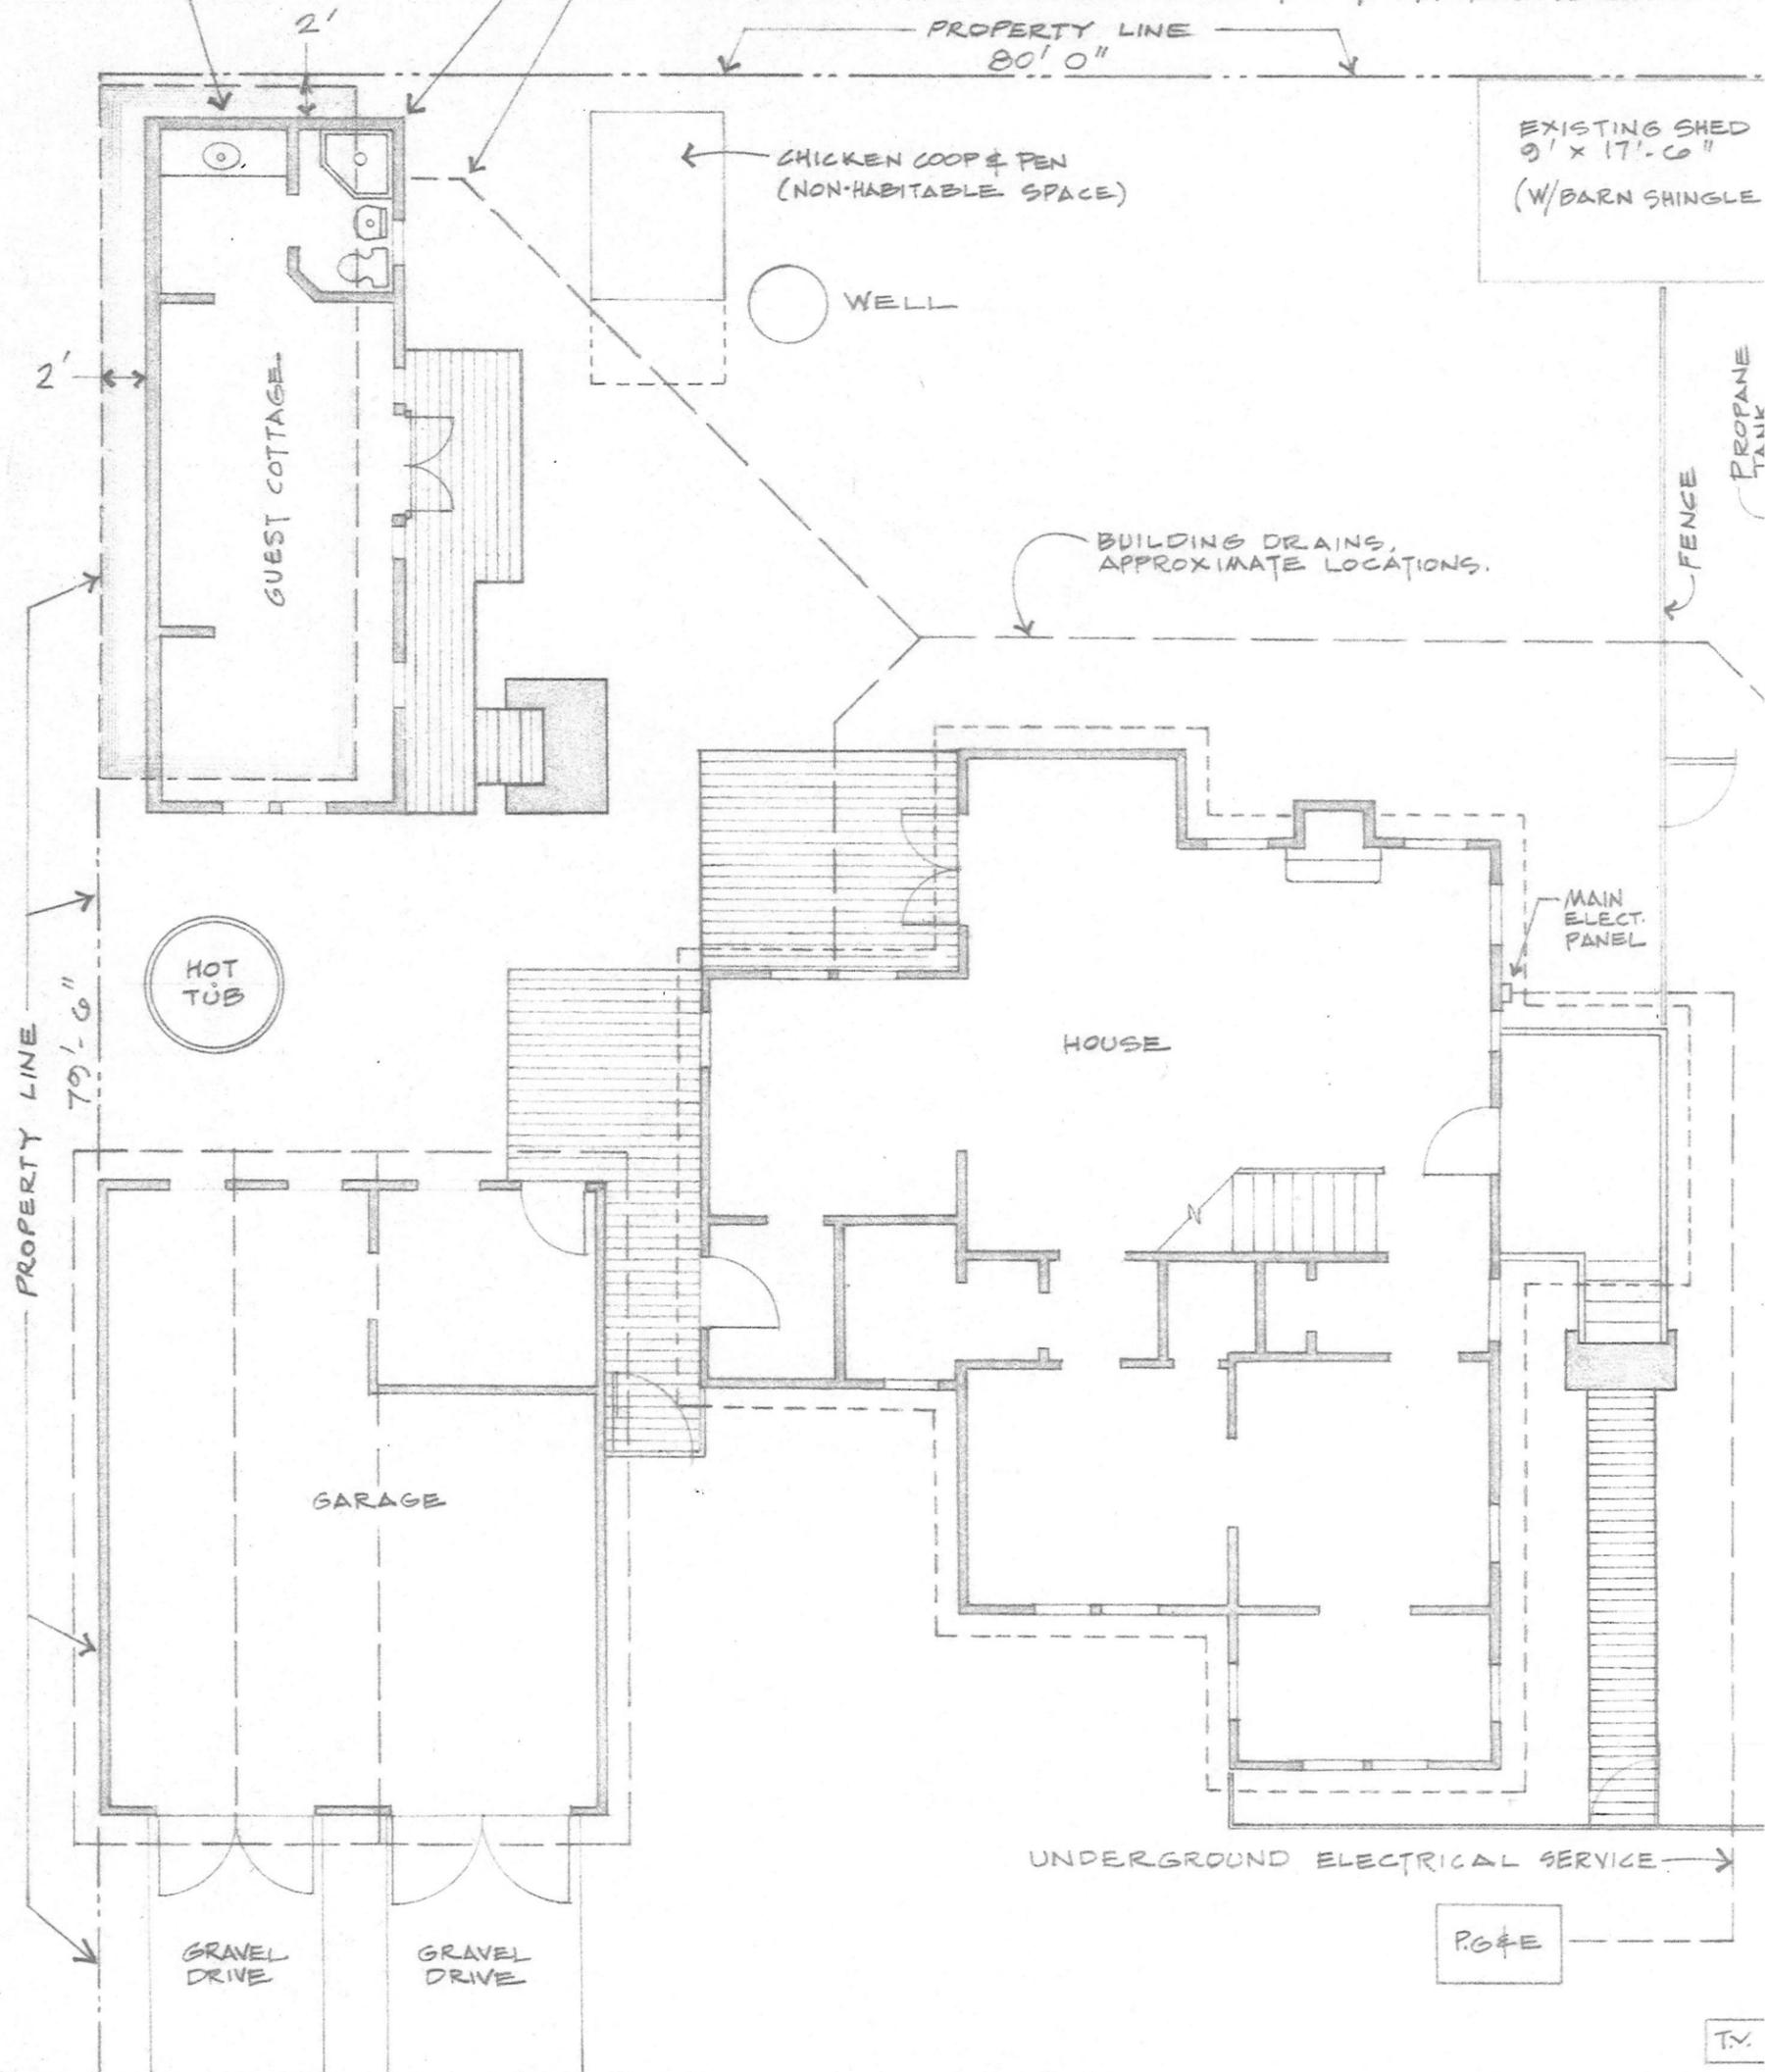
THE CURRENT, ORIGINAL LOCATION OF THE OUTBUILDING ON THE SOUTH AND EAST PROPERTY LINES IS SHOWN BY THE DASHED LINES AND SHADING

THE BUILDING WILL BE SHIFTED TWO FEET (MHRB 2015-0014 (ST JOHN)), WHICH IS ABOUT THE MINIMUM REQUIRED FOR CONSTRUCTING A CONTINUOUS FOOTING WITH A FOUNDATION DRAIN (SEE ELEVATIONS). BUILDING SITS ON INADEQUATE PIERS AT THE MOMENT.

RESTORED COTTAGE WILL BE RECONNECTED TO EXISTING SEWER LINE
